# MIDDLE EAST TECHNICAL UNIVERSITY

## Preliminary Reconnaissance Report on February 6, 2023, Pazarcık $M_w=7.7$ and Elbistan $M_w=7.6$ , Kahramanmaraş-Türkiye Earthquakes

February 20, 2023

REPORT NO: METU/EERC 2023-01

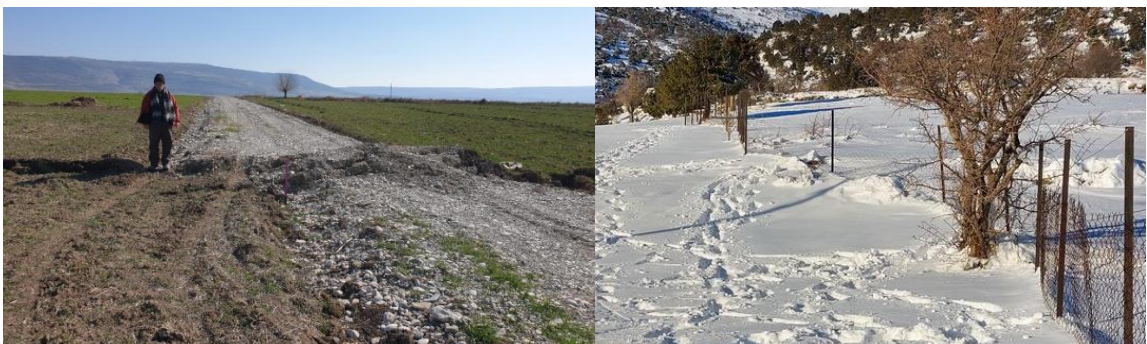
**Figure 2.2.** Photos of 2.4 m road offset near Pazarcık and 6.7 m fence offset along the Sürgü-Çardak fault segment (taken by Erdin Bozkurt and Taylan Sançar respectively).

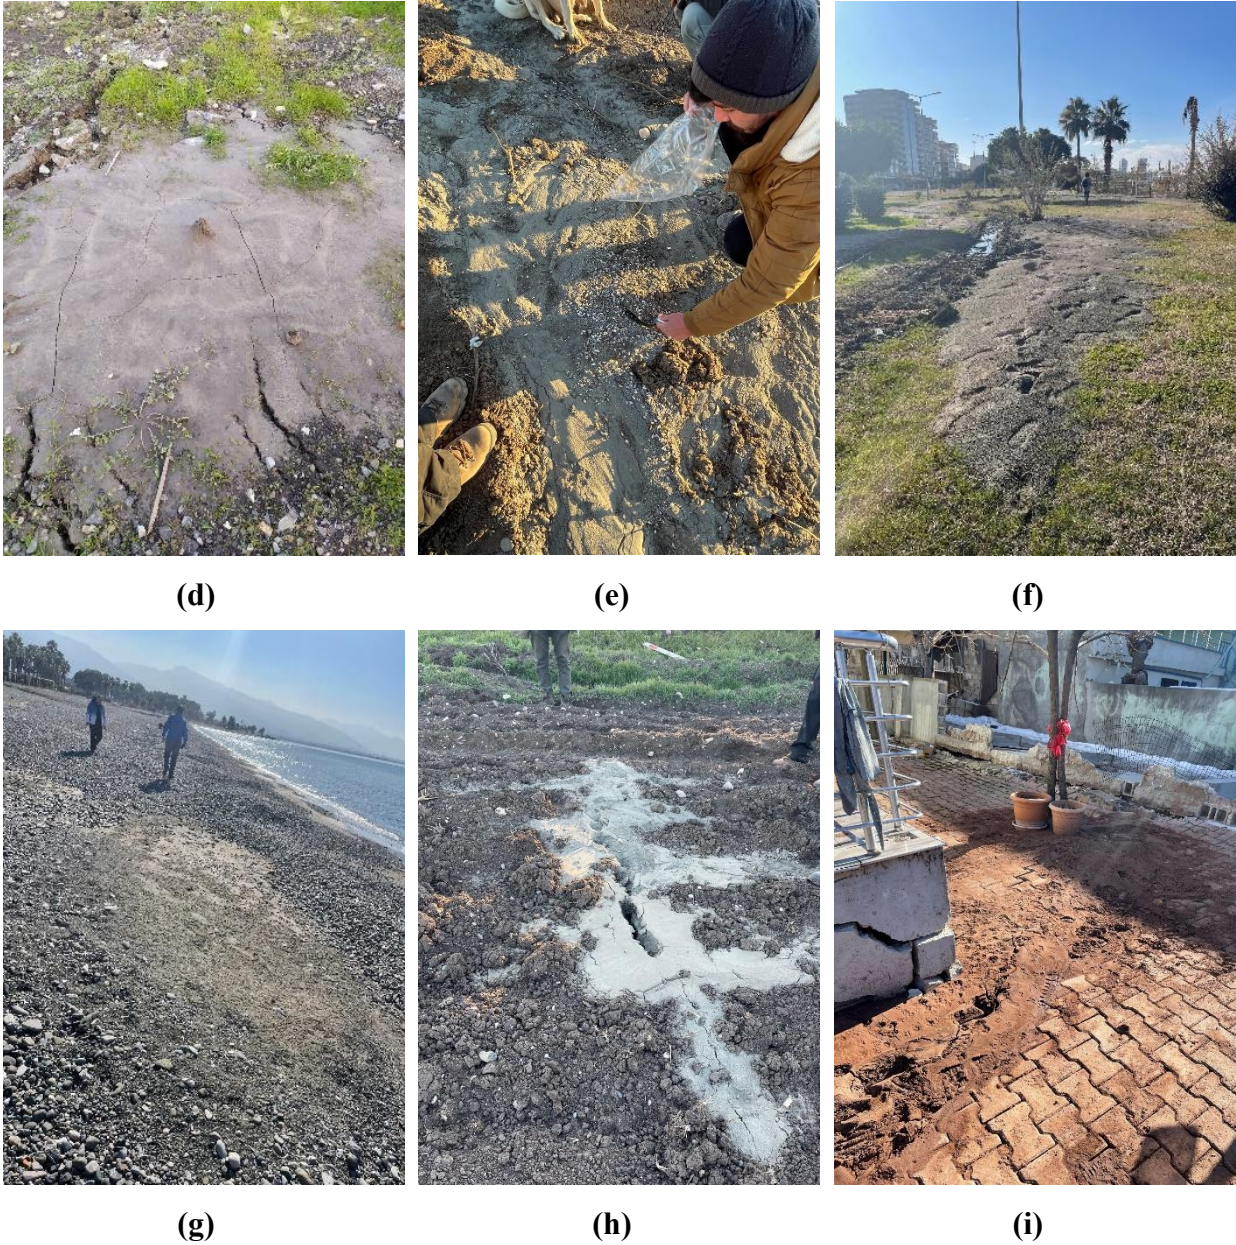
The liquefaction phenomena were widely observed in Hatay-Paşaköy, Hatay-İskenderun, Adıyaman-Gölbaşı, Adıyaman-Türkoğlu regions. Lateral spreading and subsidence were accompanied to liquefaction triggering at these sites.

**Figure 4.1.** Seismic soil liquefaction-induced surface manifestation: sand boils in free field conditions: **a)** Hatay ( $36.36446^\circ N, 36.28147^\circ E$ ), **b)** Kumlu / Hatay ( $36.35628^\circ N, 36.39360^\circ E$ ), **c)** Fatih District / Gölbaşı / Adıyaman ( $37.78080^\circ N, 37.62888^\circ E$ ), **d)** İskenderun / Hatay ( $36.59323^\circ N, 36.18542^\circ E$ ), **e)** Emiroğlu / Kahramanmaraş ( $37.33689^\circ N, 37.04538^\circ E$ ), **f)** Çay District / İskenderun / Hatay ( $36.59133^\circ N, 36.17888^\circ E$ ) **g)** Dört Yol / Hatay ( $36.81878^\circ N, 37.17770^\circ E$ ) **h)** Emiroğlu / Kahramanmaraş ( $37.33722^\circ N, 37.04549^\circ E$ ) **i)** Gölbaşı / Adıyaman ( $37.78655^\circ N, 37.63155^\circ E$ )

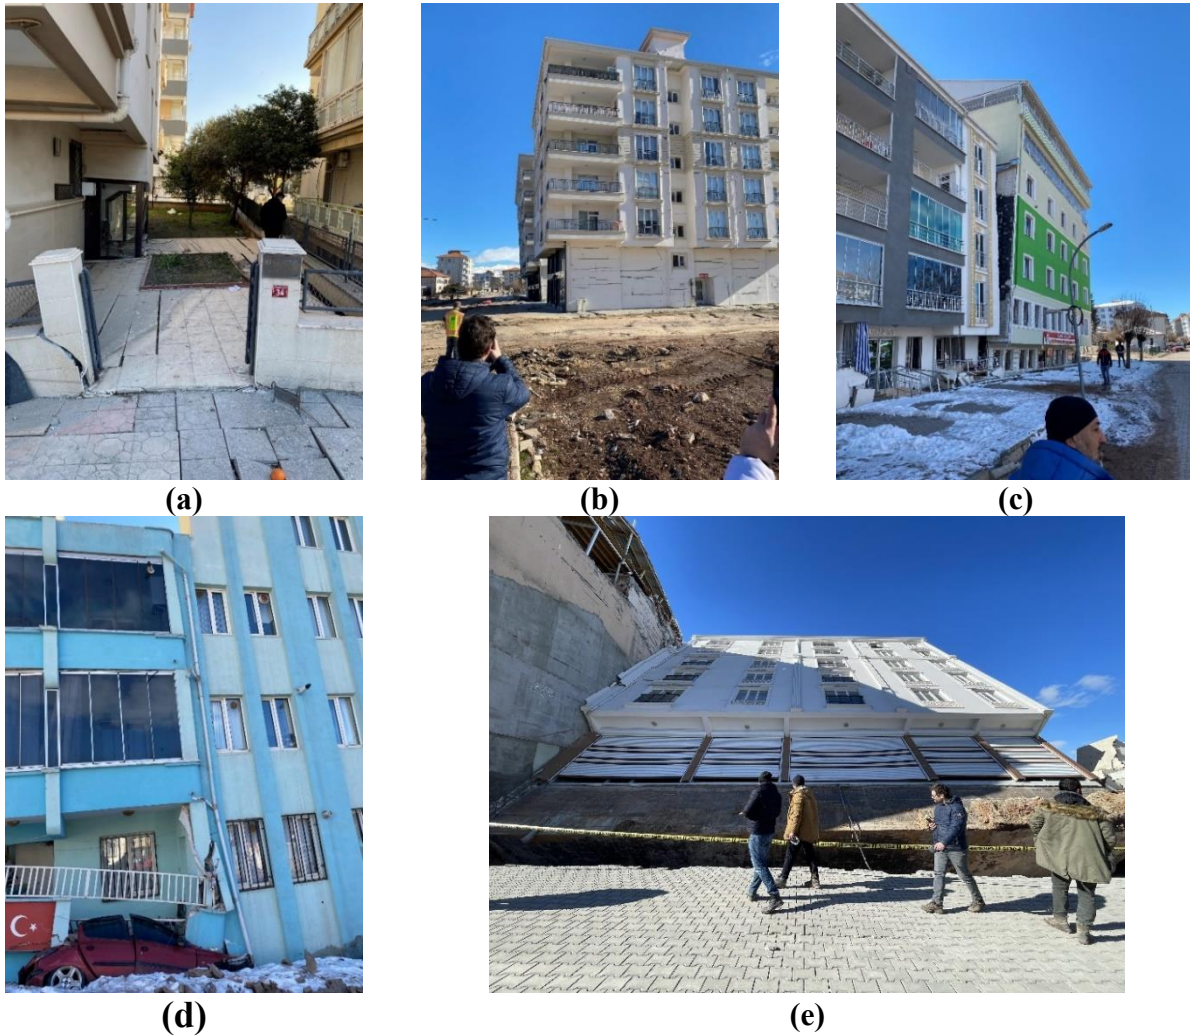
Many residential building foundations in Hatay-İskenderun, and Adıyaman-Gölbaşı regions were subjected to excessive settlements and bearing capacity failures due to seismic soil liquefaction initiation. The extent of these foundation settlements varies in the range of a couple of centimeters to an excess of 80 cm. Moreover, differential settlements reach 30 cm, causing 5 to 10 degree tilting of buildings. An extreme case of liquefaction-induced bearing capacity failure and toppling of a residential building in Adıyaman-Gölbaşı is shown in Figure 4.4 (e). Raft foundation thickness of this building is measured as 80 cm.

**Figure 4.4.** Poor foundation performance in **a)** Çay District / İskenderun / Hatay ( $36.5911^{\circ}N$ ,  $36.1790^{\circ}E$ ), **b)** Hürriyet District / Gölbaşı / Adıyaman ( $37.778^{\circ}N$   $37.628^{\circ}E$ ), **c)** Yavuz Selim District / Gölbaşı / Adıyaman ( $37.788^{\circ}N$ ,  $37.642^{\circ}E$ ), **d)** Yavuz Selim District / Gölbaşı / Adıyaman ( $37.788^{\circ}N$ ,  $37.642^{\circ}E$ ), **e)** Yavuz Selim District / Gölbaşı / Adıyaman ( $37.78827^{\circ}N$   $37.64879^{\circ}E$ )

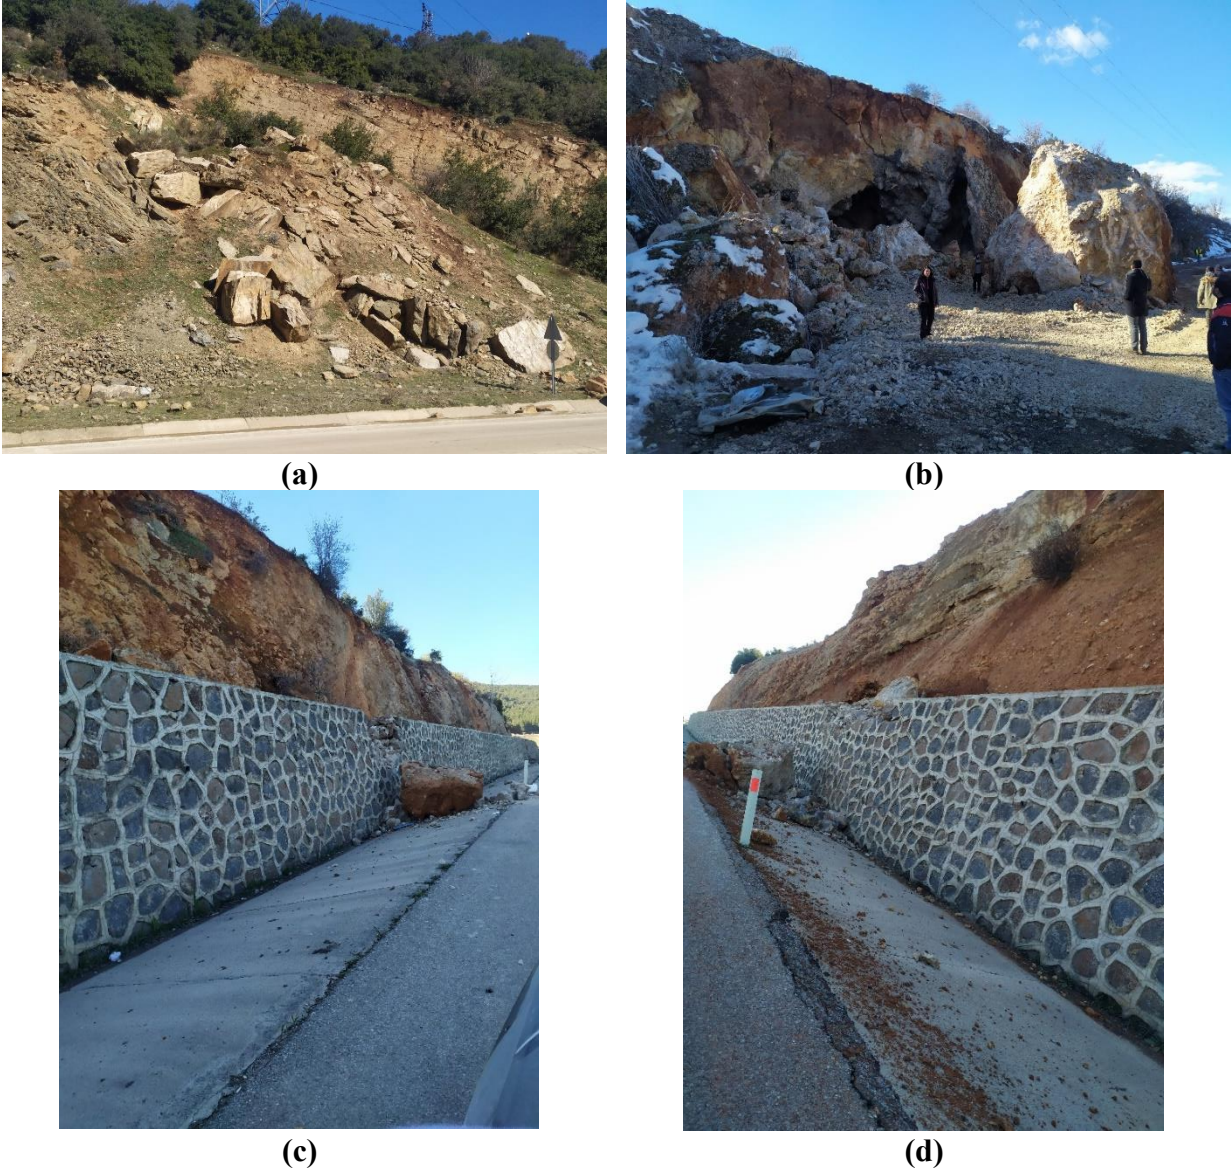
Several rockfalls were observed by the benches of highways and some examples are shown in Figures 4.7 (a) through (d).

**Figure 4.7.** Some examples of rockfalls in **a)** Bahçe / Osmaniye ( $37.17441^{\circ}N$ ,  $36.65659^{\circ}E$ ), **b)** Yolbağı District / Adıyaman ( $37.81795^{\circ}N$ ,  $37.63311^{\circ}E$ ), **c)** Fevzi Paşa District / İslahiye /Gaziantep ( $37.09899^{\circ} N$ ,  $36.65200^{\circ} E$ ), **d)** Fevzi Paşa District / İslahiye /Gaziantep ( $37.09713^{\circ} N$ ,  $36.65170^{\circ} E$ )

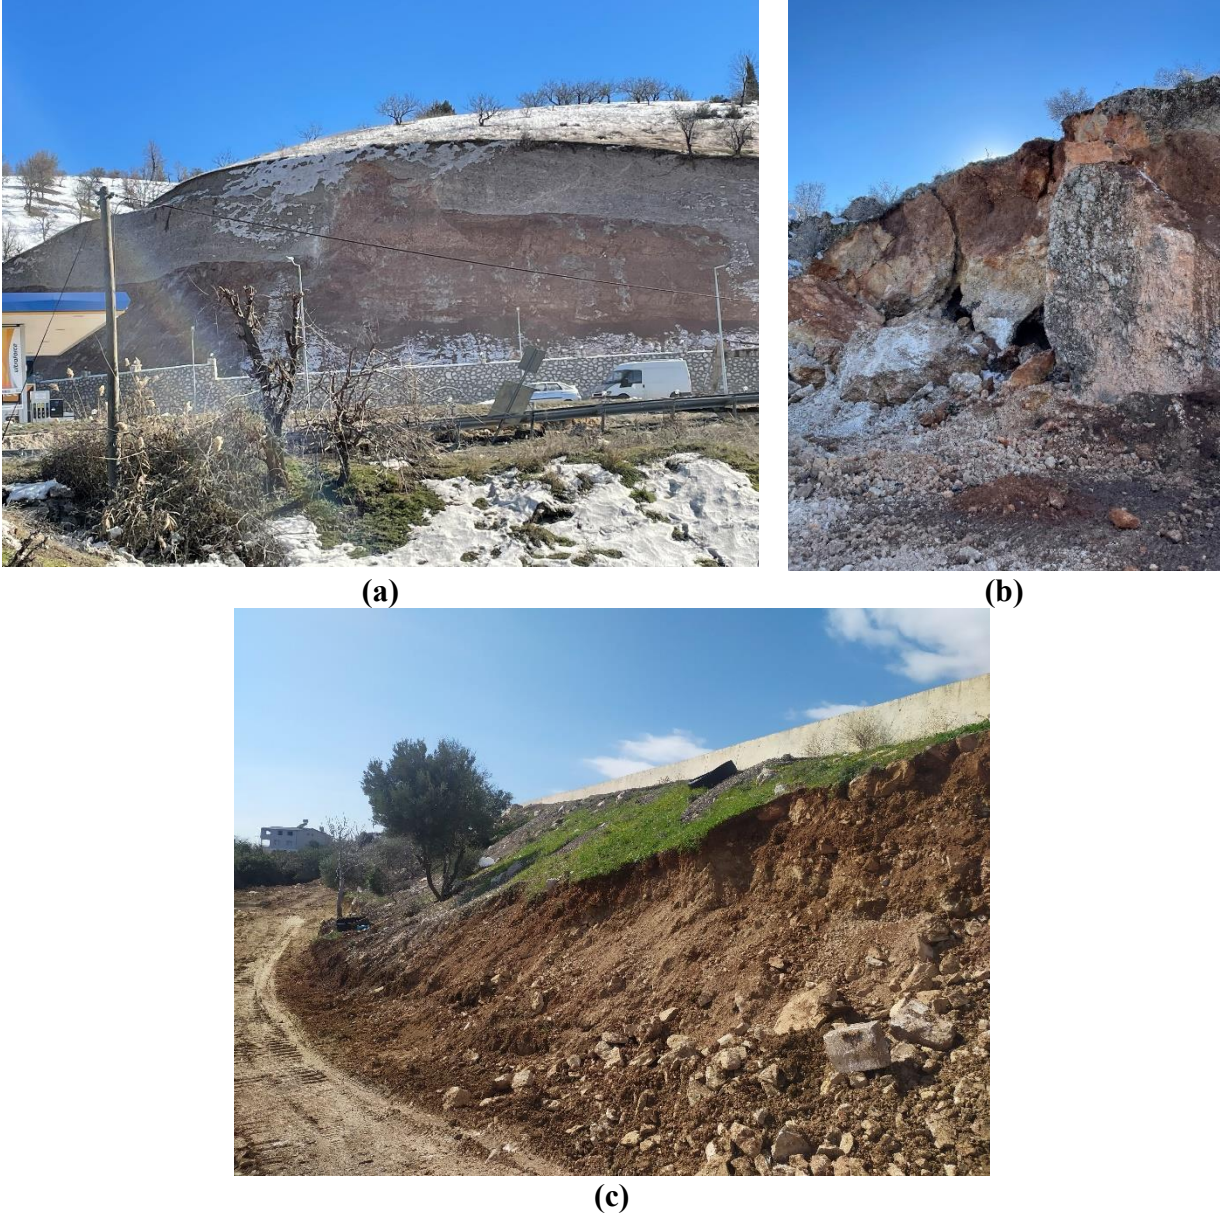
Several landslides with dimensions varying from a scale of a couple of meters to hundreds of meters were documented as part of reconnaissance studies. Some of these are shown in Figures 4.9 (a) through (c).

**Figure 4.9.** Some examples of slope stability problems in **a)** Gölbaşı/ Adıyaman ( $37.79783^{\circ}N$ ,  $37.66232^{\circ}E$ ), **b)** Yolbağı District / Adıyaman ( $37.81806^{\circ}N$ ,  $37.63297^{\circ}E$ ), **c)** Belen / Hatay ( $36.48363^{\circ}N$ ,  $36.27158^{\circ}E$ )

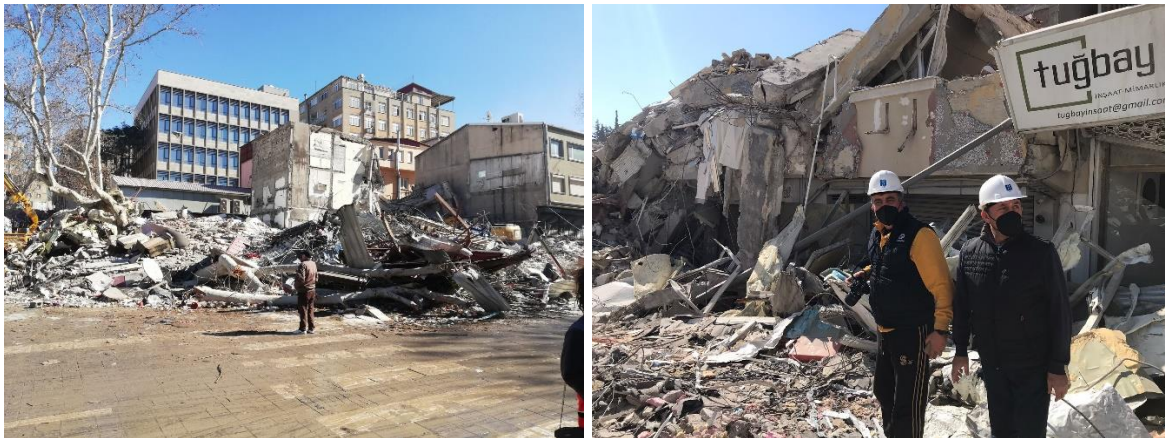
Typical deficiencies of the frame buildings constructed before 2000 were the use of smooth reinforcing bars, insufficient steel reinforcement detailing and possibly low concrete strength resulting in heavy damage and collapse (Figure 5.1). The presence of soft story in the ground level or above the plinth was one of the key reasons of collapse in many buildings. The use of the ground floors as commercial stores with little or no infill walls were responsible for plastic hinging in columns occurred resulting in pancake type collapse as observed in previous earthquakes (Kocaeli 1999, Van 2011). This is displayed in Figure 5.2. Several buildings have experienced beam-column joint failures. Another interesting type of failure was the overturning of the building from its base due the inability of transferring lateral forces to the foundation (Figure 5.3).

**Figure 5.1.** Building Collapse in Antakya and Kahramanmaraş

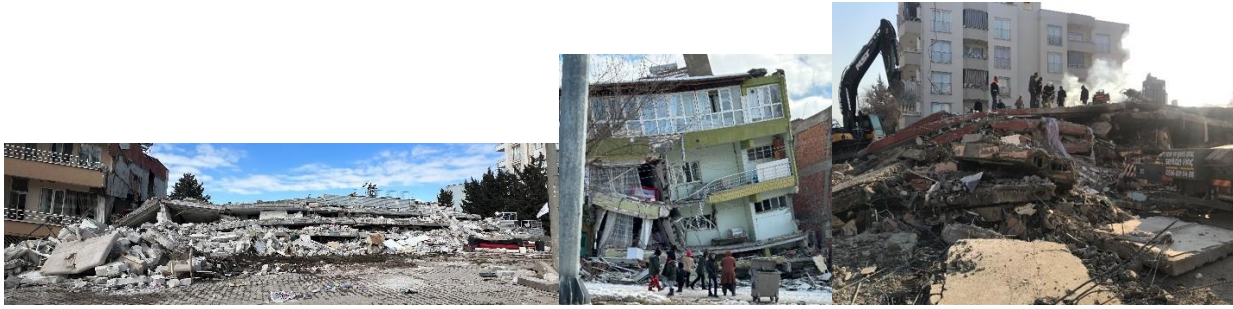
**Figure 5.2.** Building Collapse in Malatya

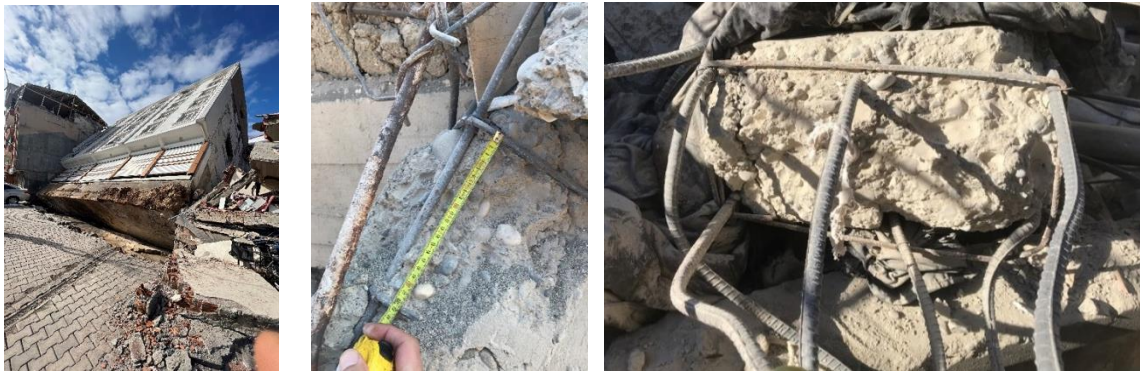
**Figure 5.3.** Overturning due to soil liquefaction and insufficient joint reinforcement detailing

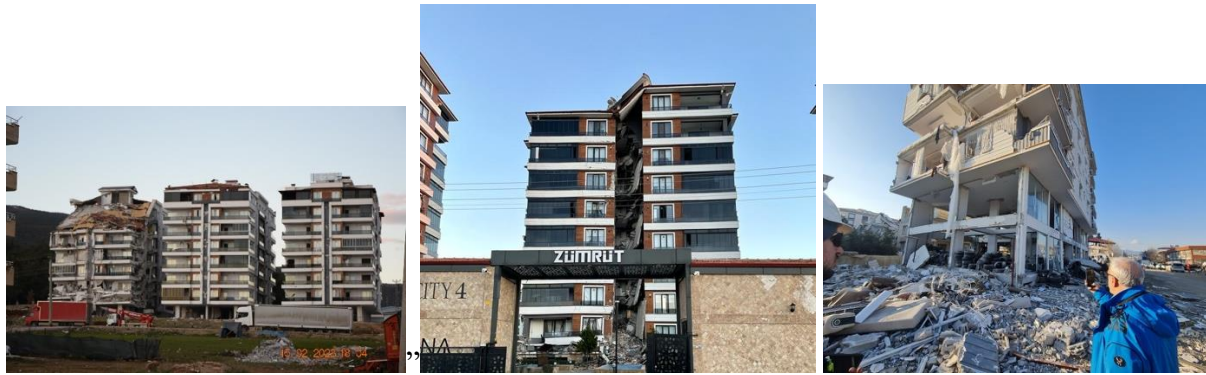
**Figure 5.4.** Heavily damaged new buildings in Adıyaman and İslahiye

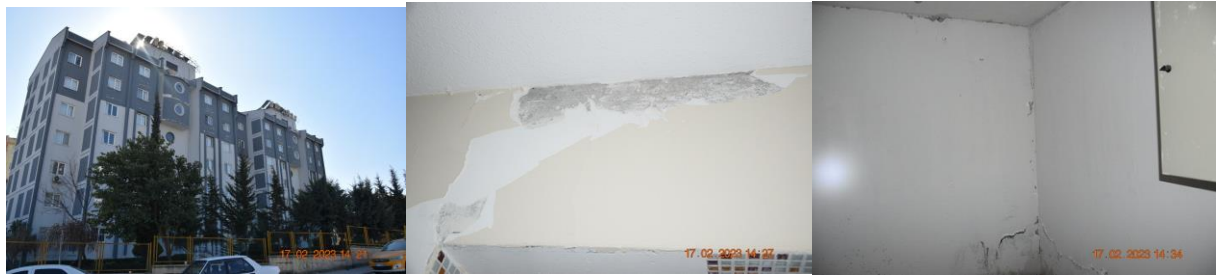
Tunnel form buildings in the region performed in an outstanding manner (Figure 5.5) with some damage in the coupling beams and infill walls due to the following key reasons: i) the use of more shear wall area more than usually 2.5% of the floor area, ii) siting at stiff soil or rock sites, iii) mid-rise construction ranging from (4 to 8 stories). This performance provided further confidence in the use of significant shear wall area for the buildings constructed in high seismic zones.

**Figure 5.5.** Performance of a tunnel form building

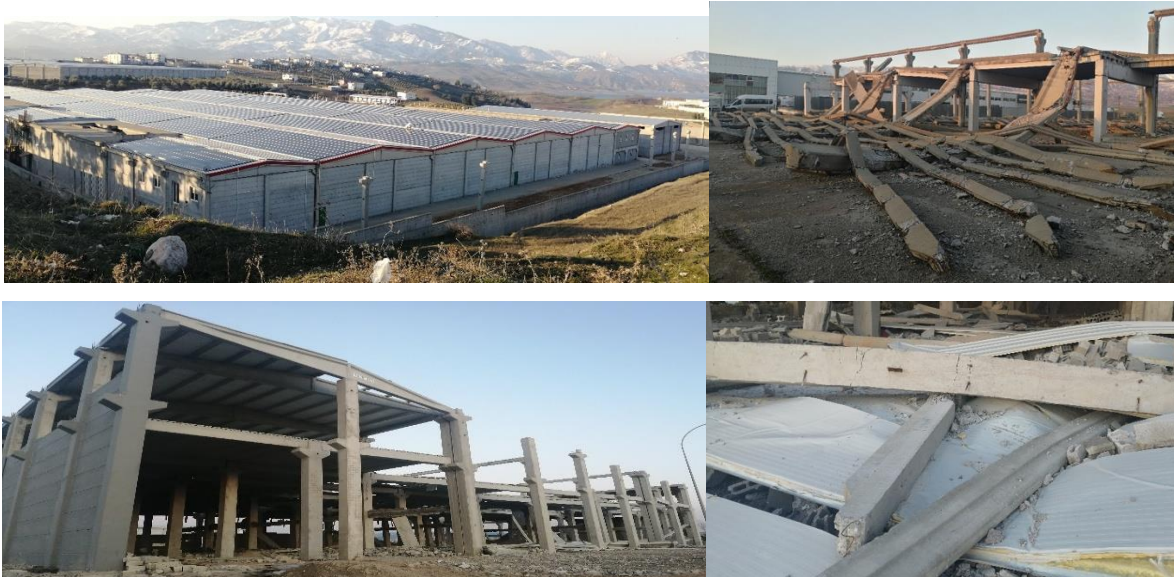
**Figure 5.6.** Overview of precast industrial building connection damage in Kahramanmaraş

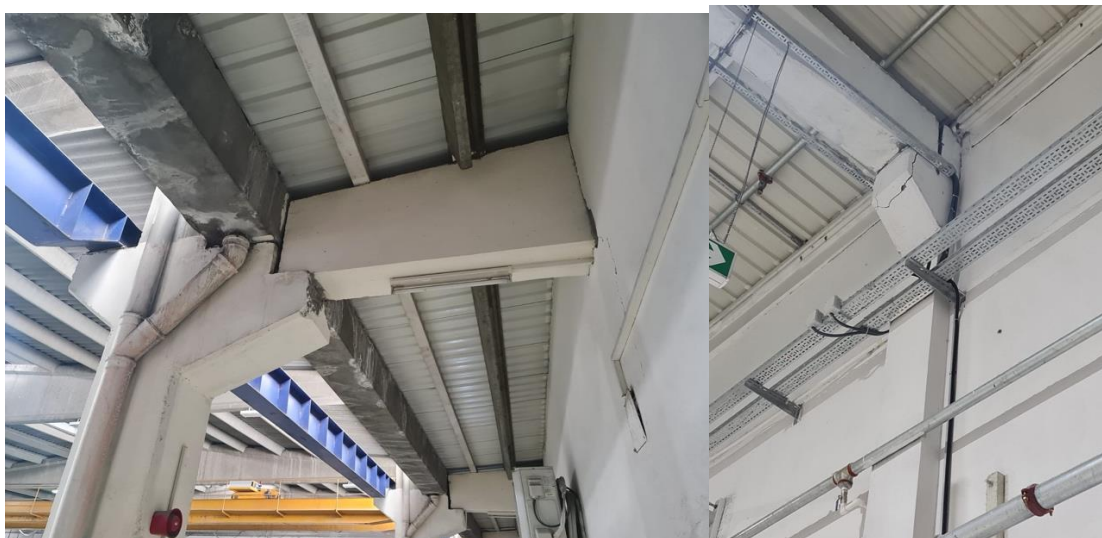
**Figure 5.7.** Corbel damages in Gaziantep

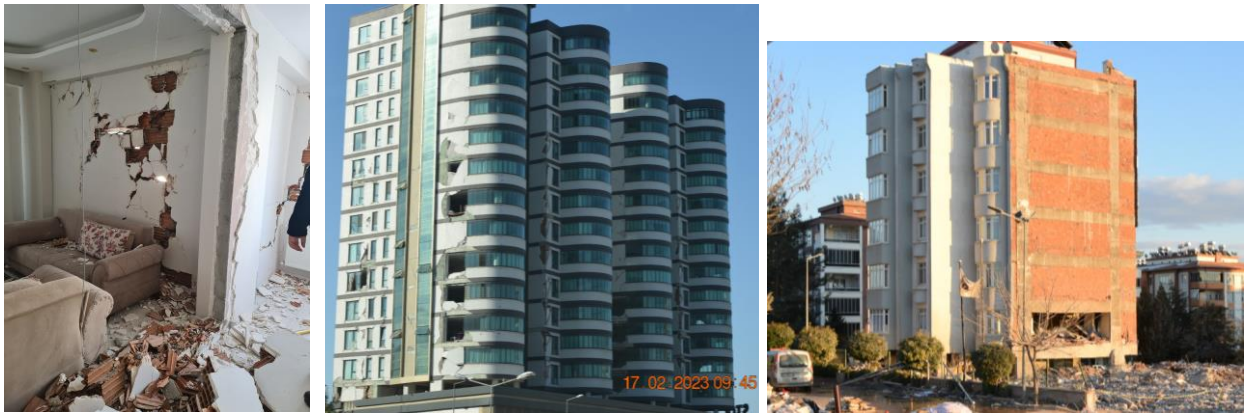
**Figure 5.8.** Infill wall damage examples

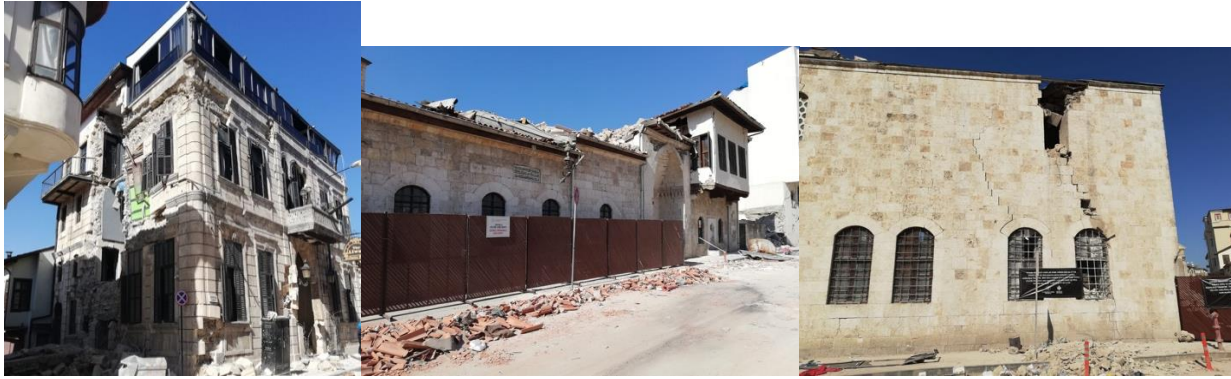
**Figure 5.9.** Damage in masonry structures

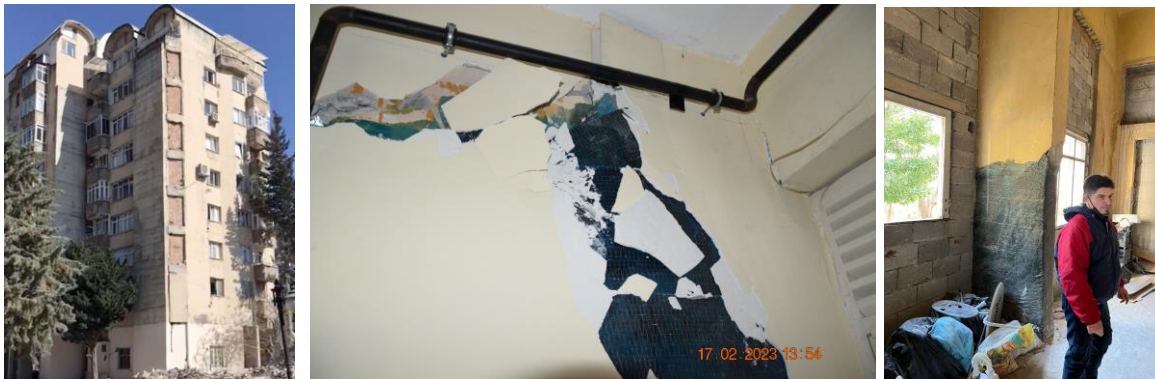
**Figure 5.10.** Performance of the strengthened building in Hatay

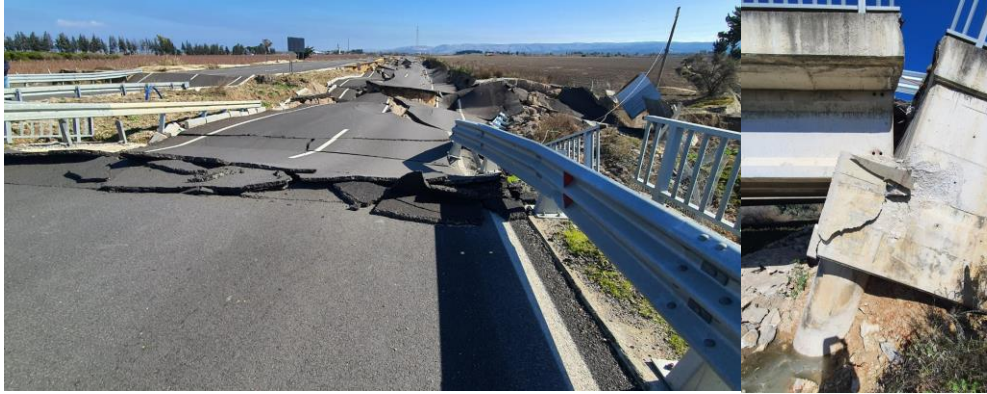
**Figure 6.1.** Abutment rotation due to seismic soil liquefaction induced foundation failure

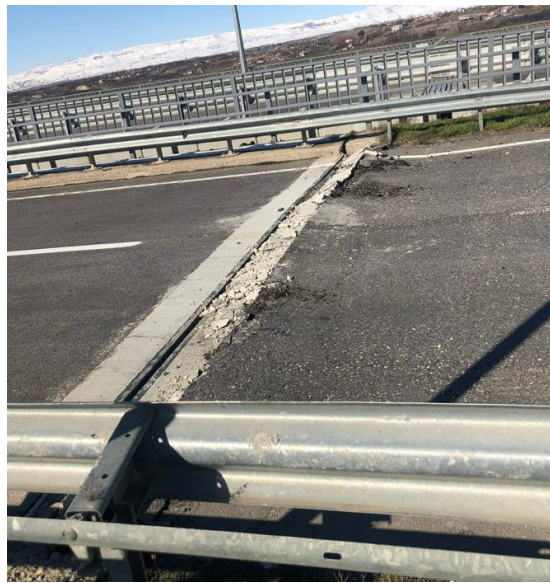
**Figure 6.2.** Joint movements

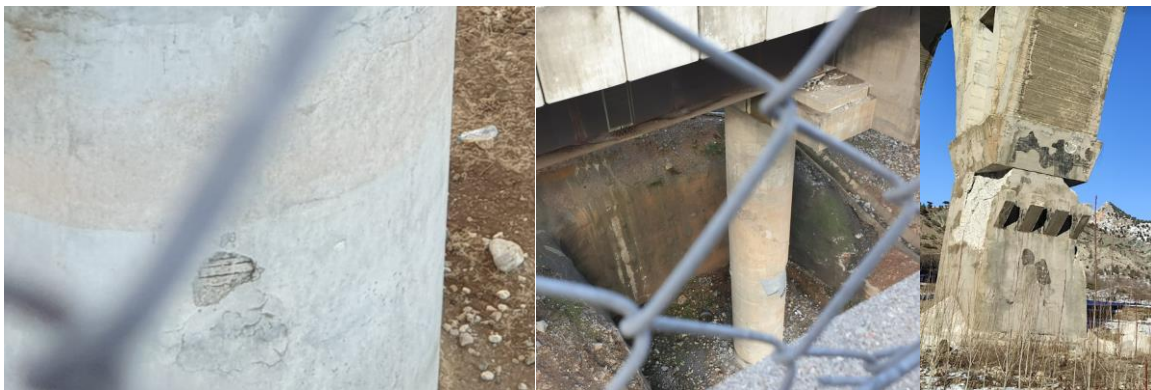
**Figure 6.3.** Concrete spalling

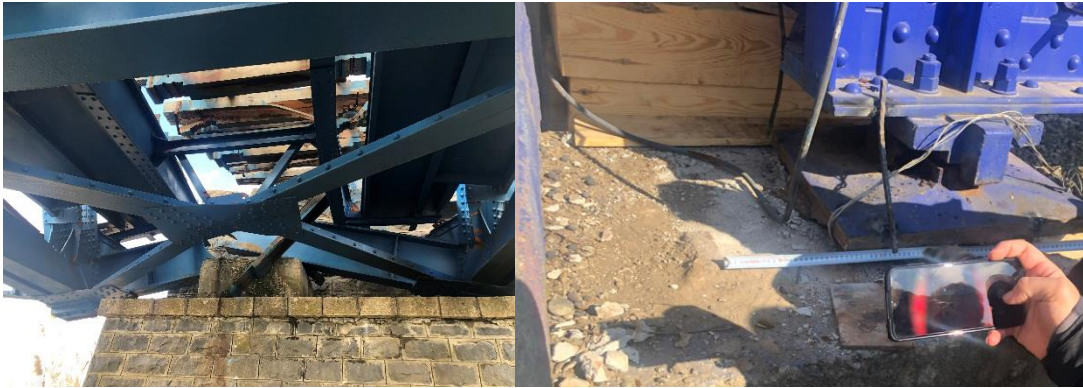
**Figure 6.4.** Bearing dislocation and movement

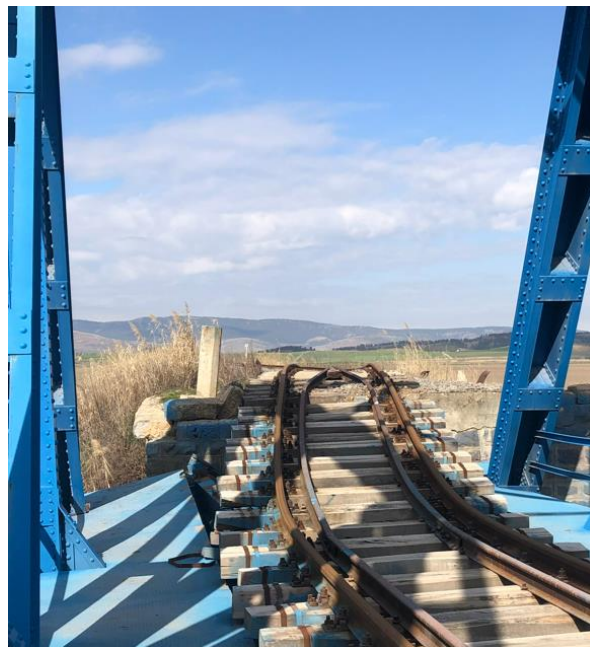
**Figure 6.5.** Rail misalignment

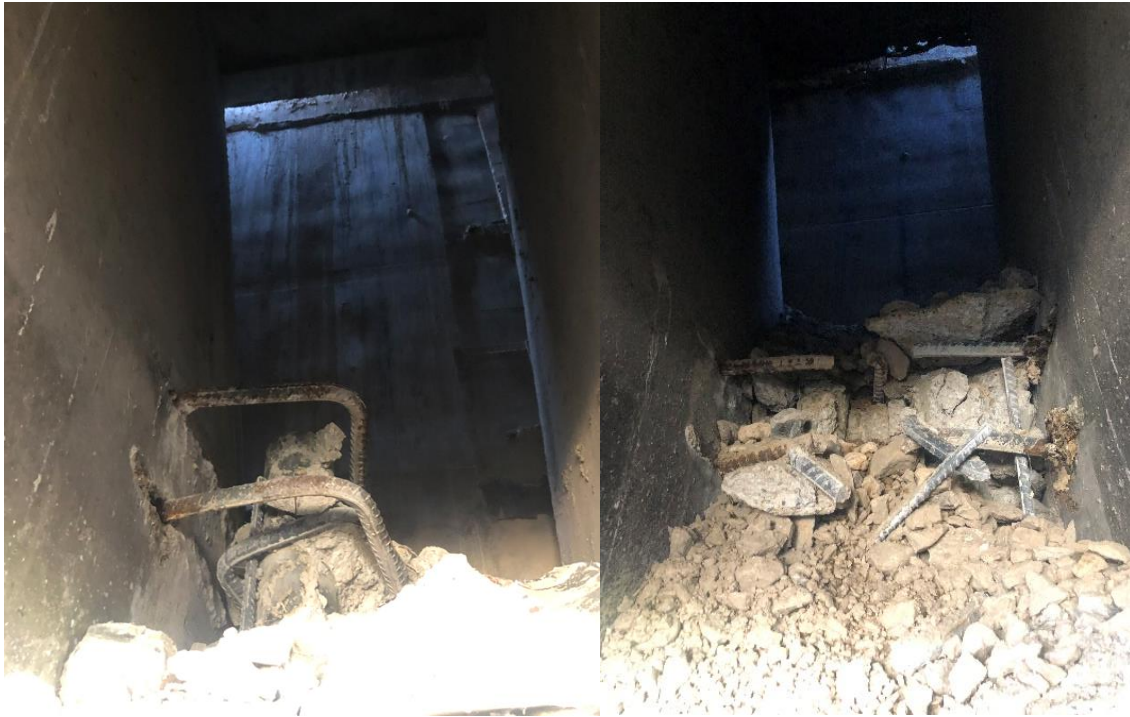
**Figure 6.6.** Shear key damage

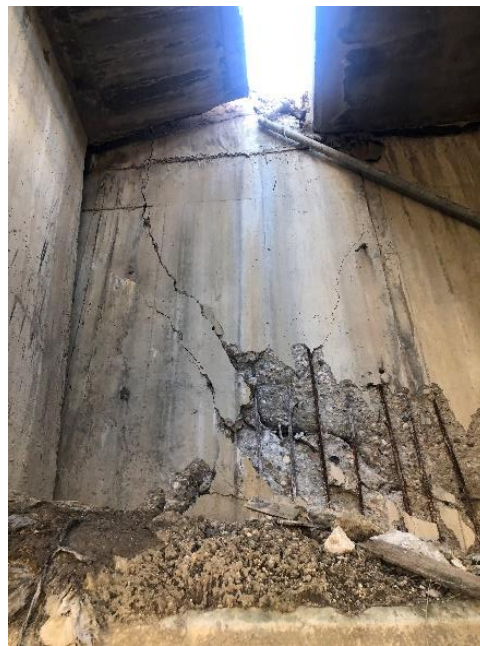
**Figure 6.7.** Abutment wall concrete spalling

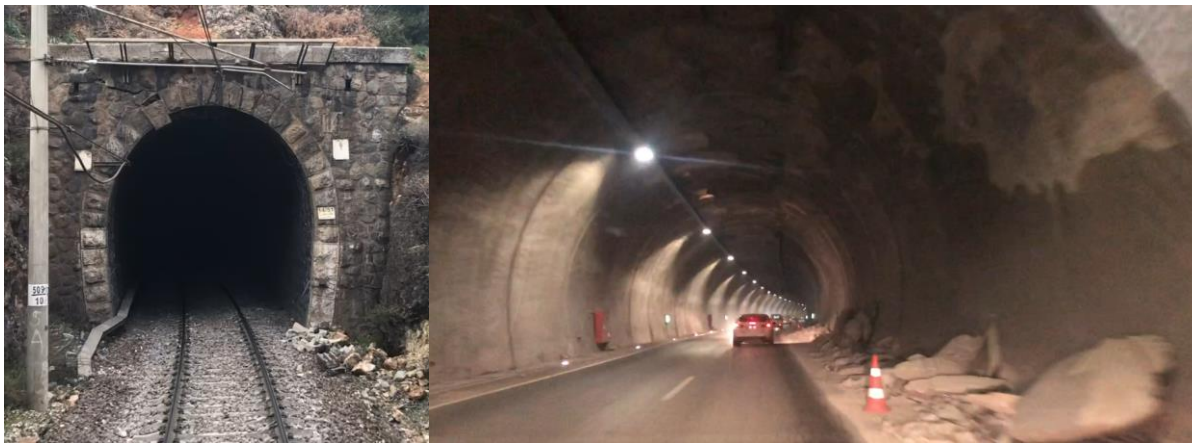
**Figure 6.9.** Tunnel portal movement and concrete spalling

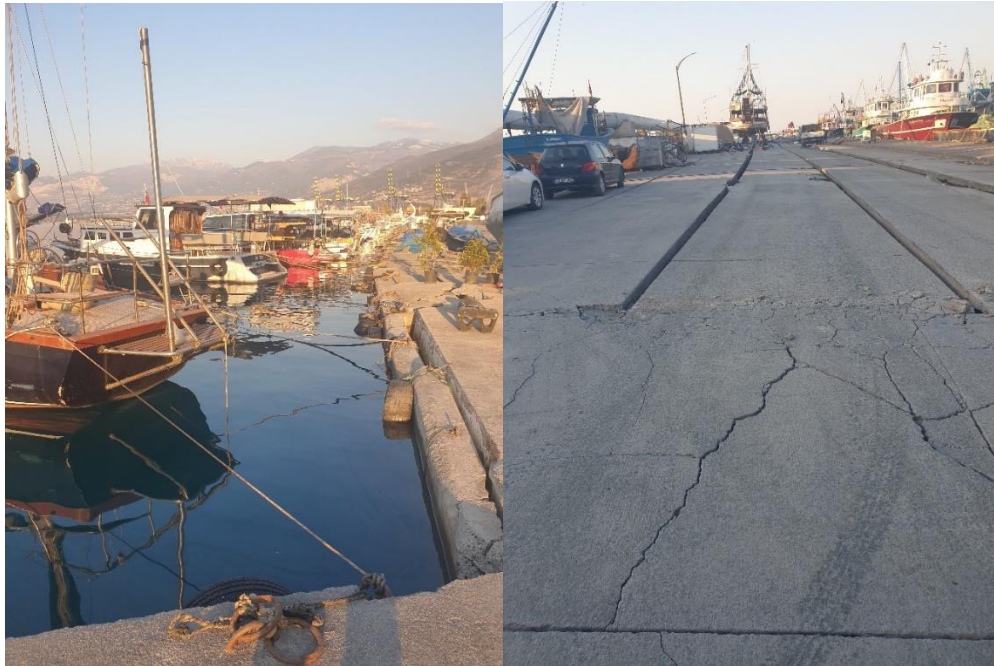
**Figure 7.4** Structural damage at İskenderun Fishery Port

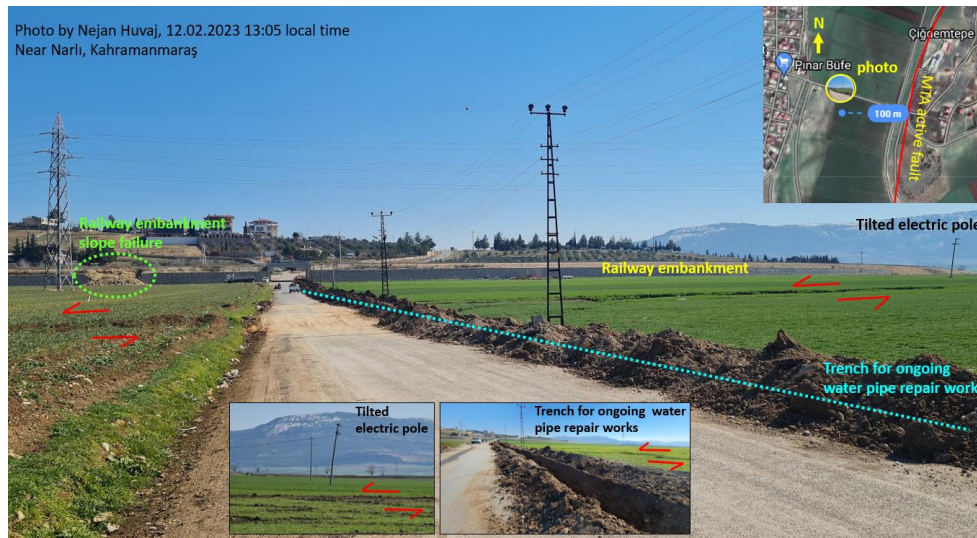
**Figure 8.3.** Referring to Figure 2 for locations of the photos: offset on the road due to surface fault rupture, railway embankment slope instability, water pipeline repair works and a tilted electric pole can be seen, near Narlı, Kahramanmaraş. (Active fault data is taken from Emre et al. (2013) published by the General Directorate of Mineral Research and Exploration, MTA (Maden Tetkik ve Arama Genel Müdürlüğü)).

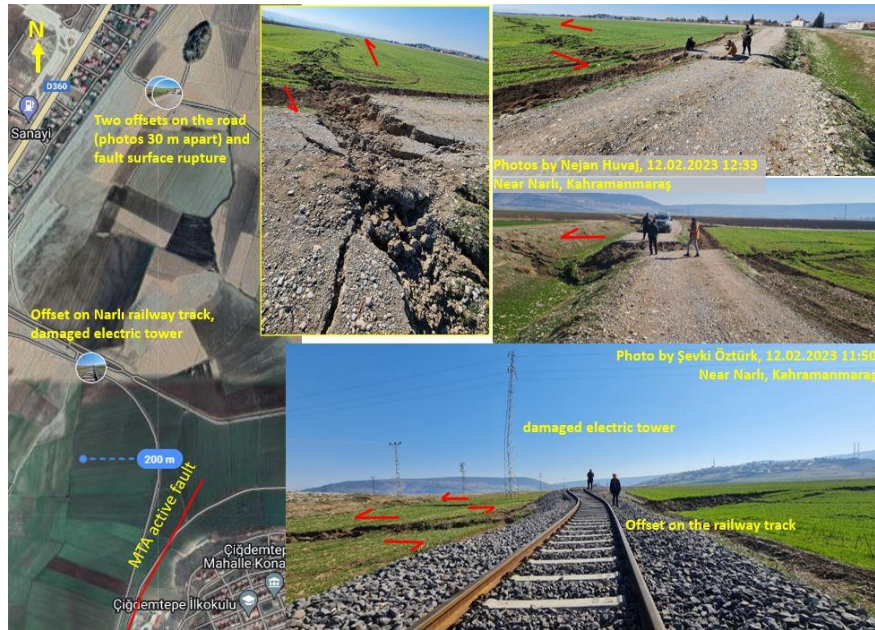
**Figure 8.4.** Surface rupture, offset, cracks and damages on railway tracks and roads, as well as a damaged electric tower, near the surface rupture (Narlı, Kahramanmaraş). (Active fault data is taken from Emre et al. (2013)).

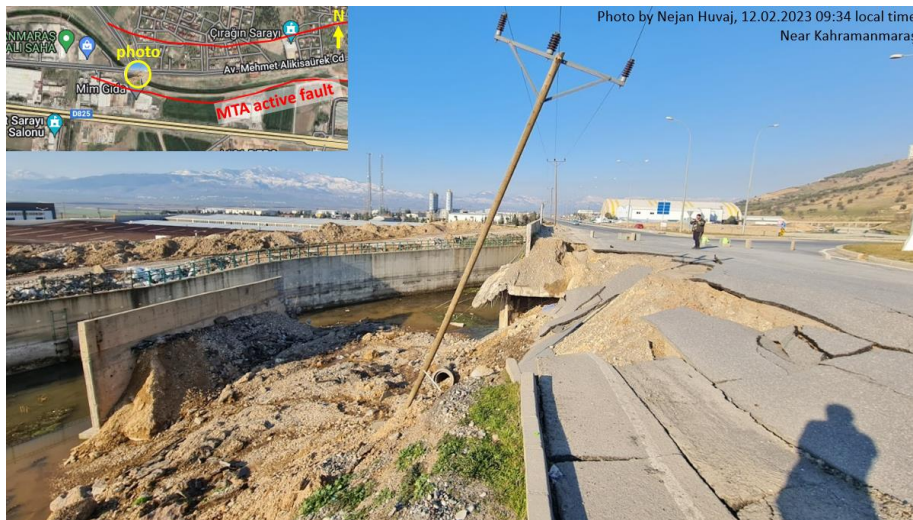
**Figure 8.5.** A landslide and crack/damages on the road next to a water canal, causing significant lateral displacement of a concrete retaining wall (pushed towards the water canal), a tilt on an electric pole, in southern part of the city of Kahramanmaraş (active fault data from Emre et al. (2013)).

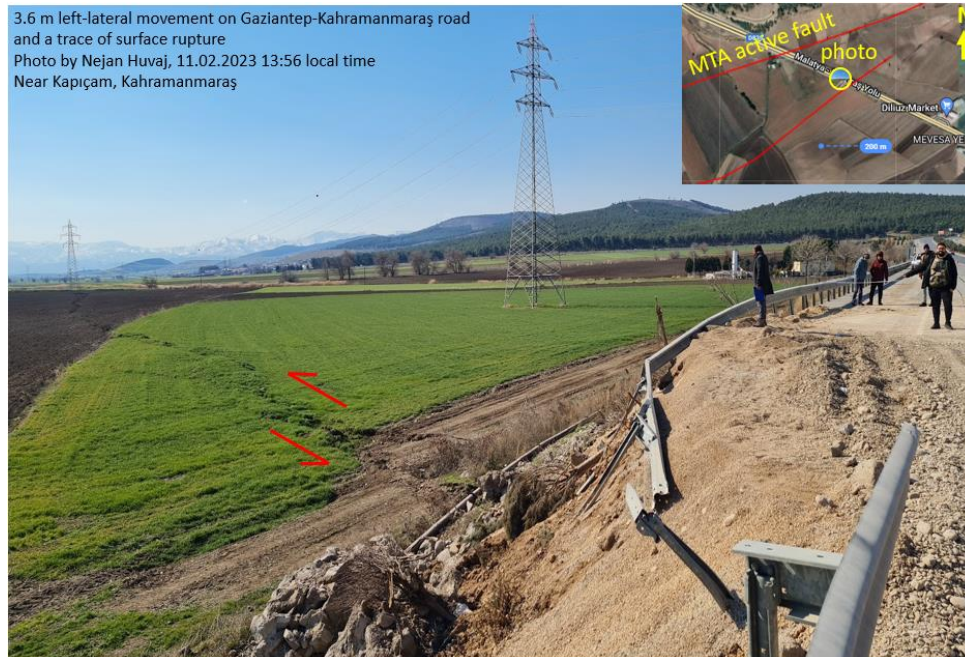
**Figure 8.7.** Referring to Figure 6 for the location: surface rupture observations and 3.6 m offset on Gaziantep-Kahramanmaraş road (active fault data from Emre et al. (2013)).

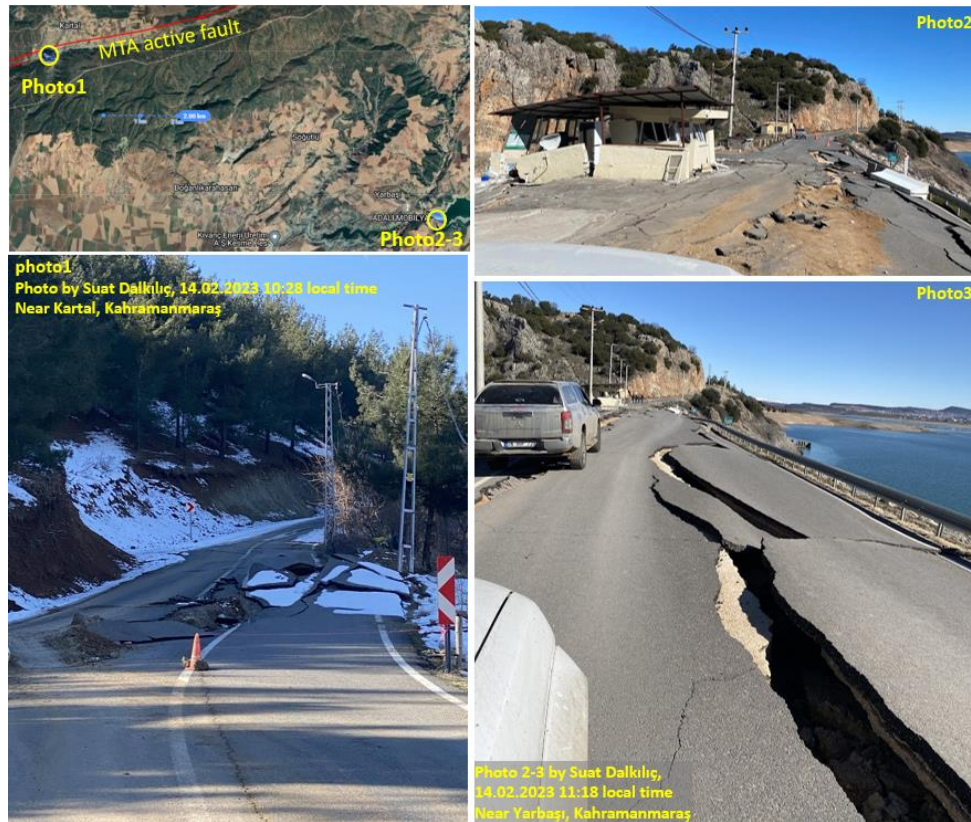
**Figure 8.8.** Landslides and surface cracks on the roads, near Kartal and Yarbaşı, Kahramanmaraş (Active fault data from Emre et al. (2013)).

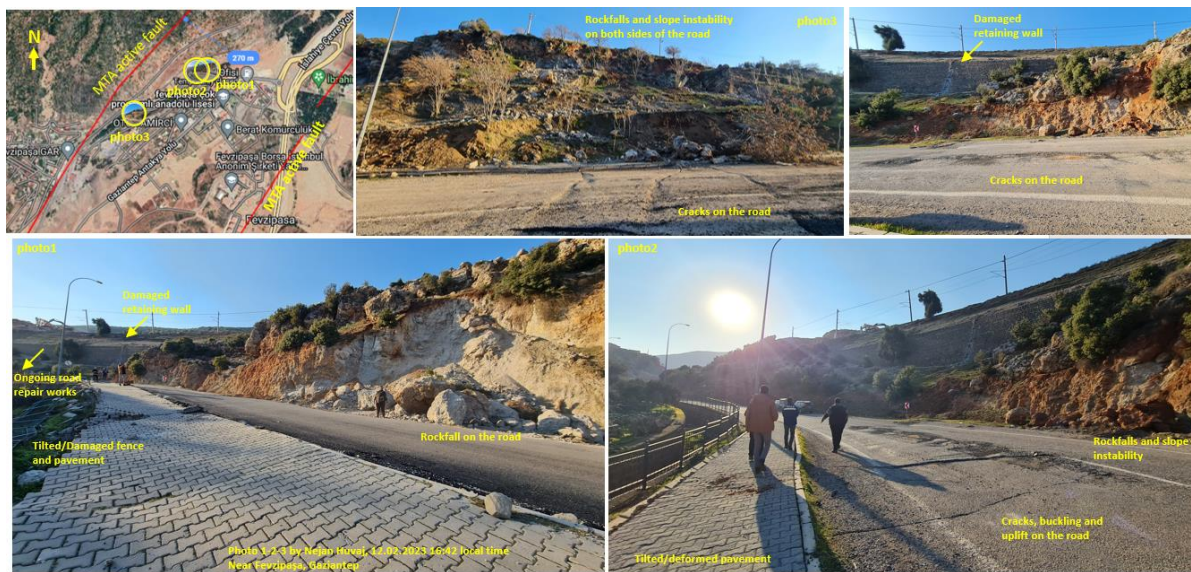
**Figure 8.9.** Landslides, rockfalls and surface cracks on the roads, near Fevzipaşa, Gaziantep causing disruption in the service (Active fault data from Emre et al. (2013)).

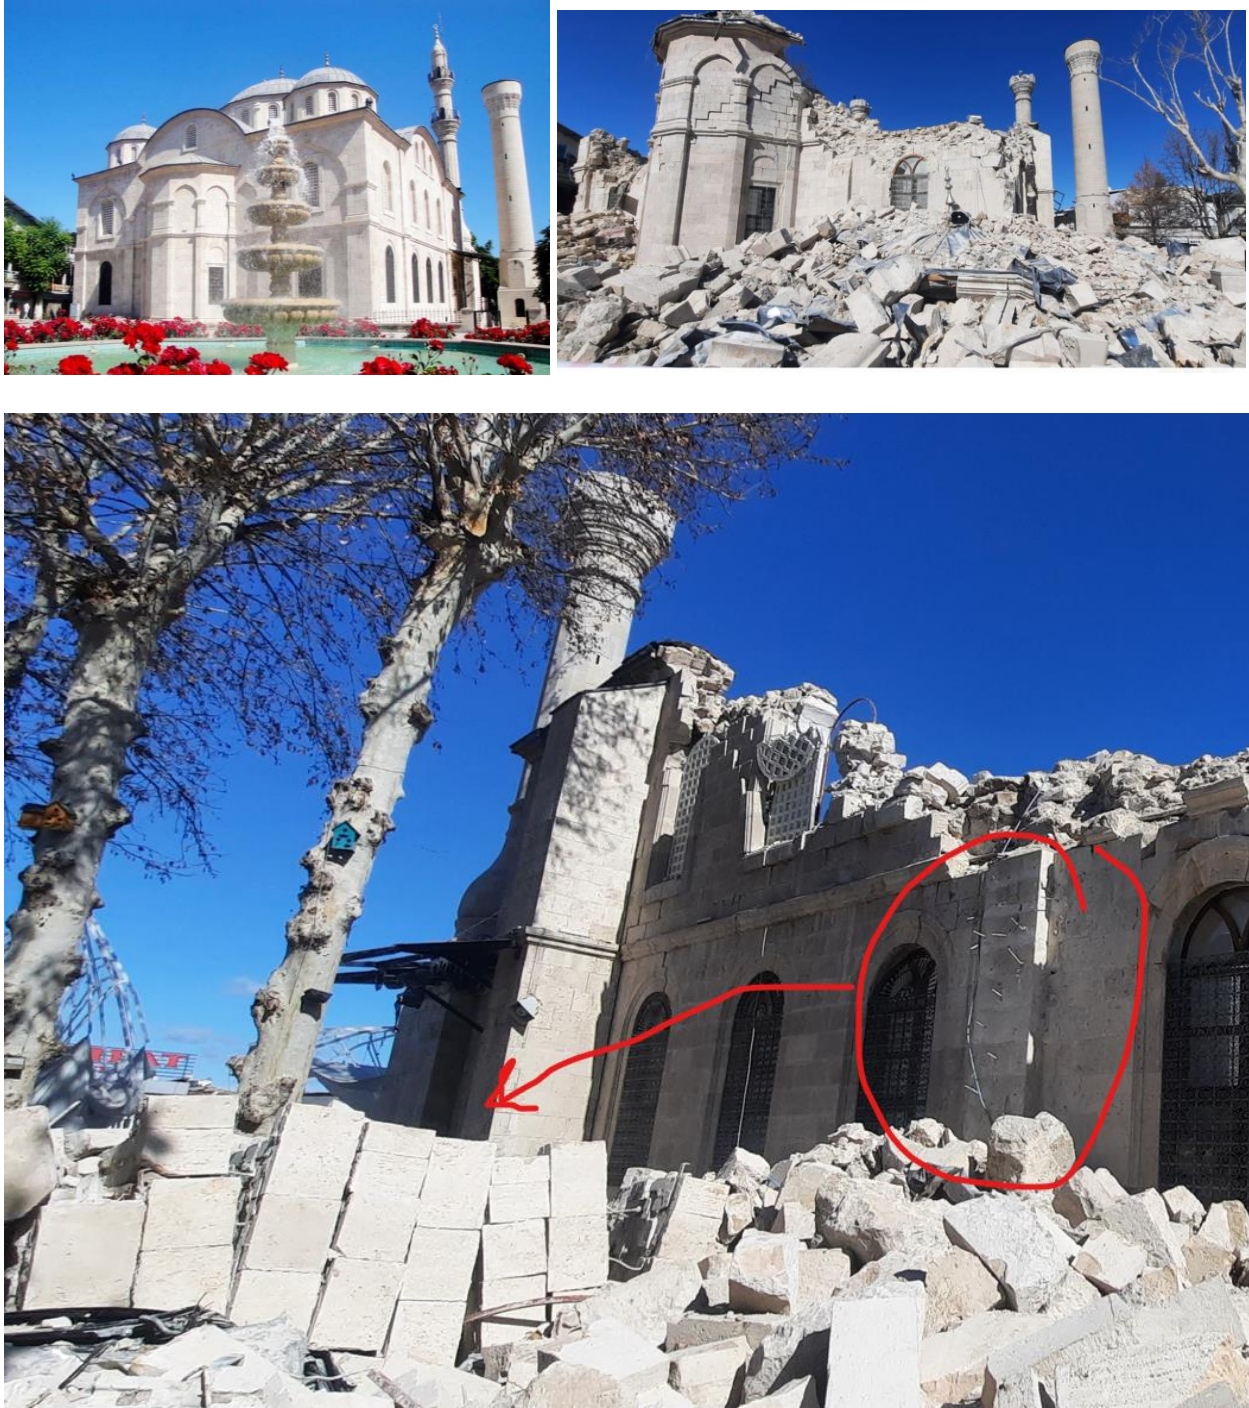
**Figure 9.4.** Yeni Cami (new mosque) before and after pictures and short anchorage.
