# MIDDLE EAST TECHNICAL UNIVERSITY

## Preliminary Reconnaissance Report on February 6, 2023, Pazarcık $M_w=7.7$ and Elbistan $M_w=7.6$ , Kahramanmaraş-Türkiye Earthquakes

February 20, 2023

REPORT NO: METU/EERC 2023-01

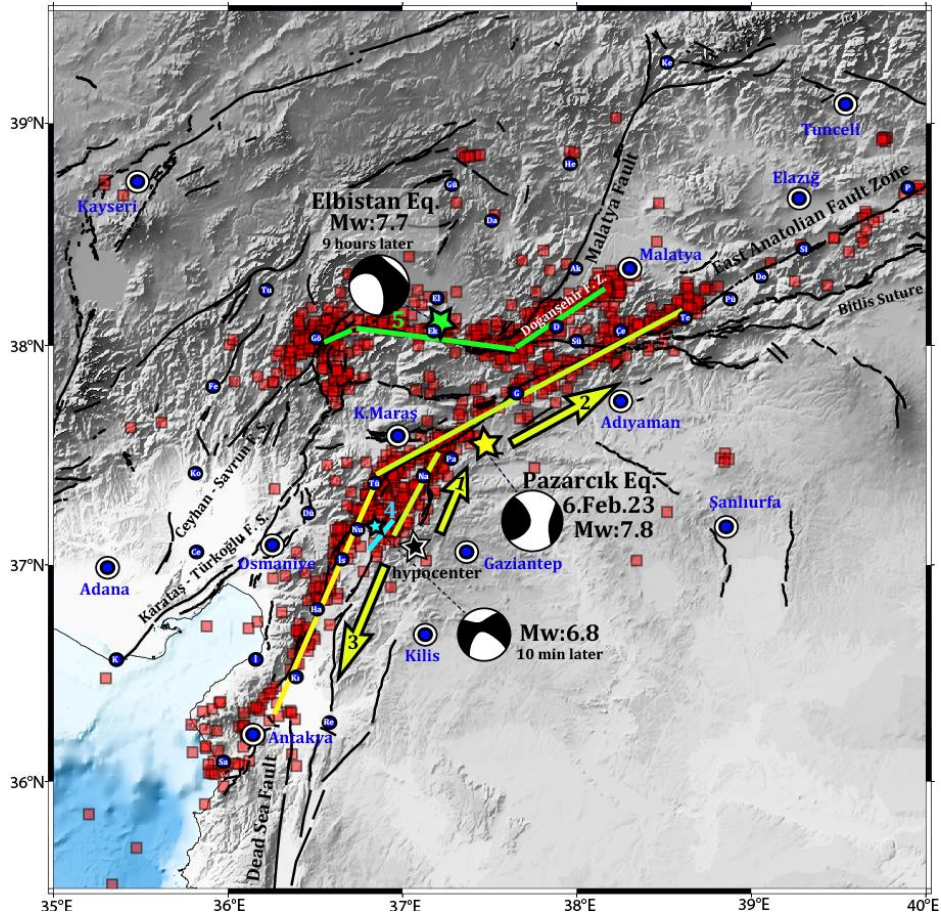
On February 6, 2023, 01:47 UTC, a large earthquake ( $M_w: 7.8$ ) occurred near Pazarcık, Kahramanmaraş. The event hypocenter is located south of the EAFZ at 37.1123N, 37.1195E according to KOERI (Figure 2.1). Moment tensor solution revealed almost pure left-lateral strike-slip motion on a nearly vertical NE-SW trending fault. According to seismic data, this earthquake initiated on a smaller Narlı fault in the south jumped to the north and ruptured the Pazarcık-Erkenek fault segments towards NE and the Amanos segment towards SW with some time delay. This earthquake displays directivity effects over the edges of the rupture and discontinuous time

Nine hours later (10:24 UTC), the Elbistan earthquake ( $M_w=7.7$ ) occurred along the Çardak-Sürgü fault segment, exhibiting a unique example of short-term earthquake triggering. The event hypocenter is located south of Elbistan near Ekinözü at 38.0717N, 37.2063E by KOERI (Figure 2.1). Like the previous event, the moment tensor solution suggested almost pure left-lateral strike-slip motion. Seismic data indicate that the earthquake initially ruptured the ~E-W trending Çardak fault which strike more southwards in the west and continued eastward towards Malatya on the NE-SW trending Doğanşehir fault zone. It is also worth noting that aftershocks on the western rupture tip are curving further down towards the south and imply possible activation of faults with different orientations (Figure 2.1). The total rupture length is around 160 km with major surface displacements on the order of 2 - 8 m.

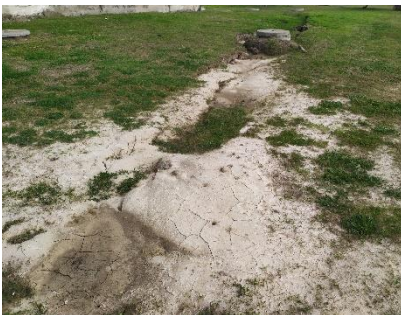
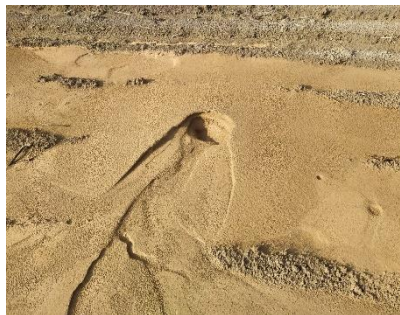
Seismic soil liquefaction-induced surface manifestations in the form of ejecta, lateral spreading, and subsidence were observed, as displayed in Figure 4.1 through Figure 4.3. Some of these manifestations were observed as in Figure 4.1 at free field sites. In addition to free field sites, liquefaction surface manifestations were also observed in the vicinity of building foundations. Figure 4.3 display the ejecta observed at the edges of residential building foundations.

The liquefaction phenomena were widely observed in Hatay-Paşaköy, Hatay-İskenderun, Adıyaman-Gölbaşı, Adıyaman-Türkoğlu regions. Lateral spreading and subsidence were accompanied to liquefaction triggering at these sites.

**Figure 4.1.** Seismic soil liquefaction-induced surface manifestation: sand boils in free field conditions: **a)** Hatay ( $36.36446^\circ N, 36.28147^\circ E$ ), **b)** Kumlu / Hatay ( $36.35628^\circ N, 36.39360^\circ E$ ), **c)** Fatih District / Gölbaşı / Adıyaman ( $37.78080^\circ N, 37.62888^\circ E$ ), **d)** İskenderun / Hatay ( $36.59323^\circ N, 36.18542^\circ E$ ), **e)** Emiroğlu / Kahramanmaraş ( $37.33689^\circ N, 37.04538^\circ E$ ), **f)** Çay District / İskenderun / Hatay ( $36.59133^\circ N, 36.17888^\circ E$ ) **g)** Dört Yol / Hatay ( $36.81878^\circ N, 37.17770^\circ E$ ) **h)** Emiroğlu / Kahramanmaraş ( $37.33722^\circ N, 37.04549^\circ E$ ) **i)** Gölbaşı / Adıyaman ( $37.78655^\circ N, 37.63155^\circ E$ )

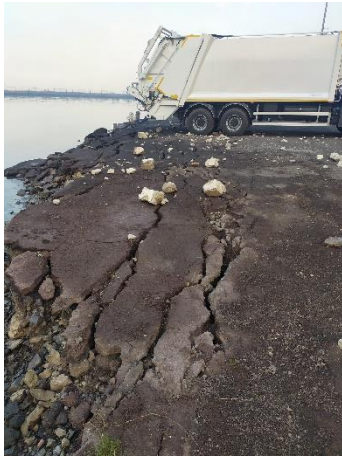
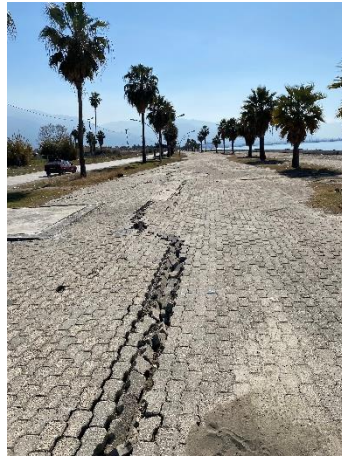
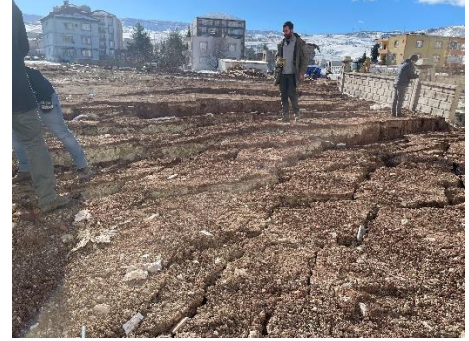
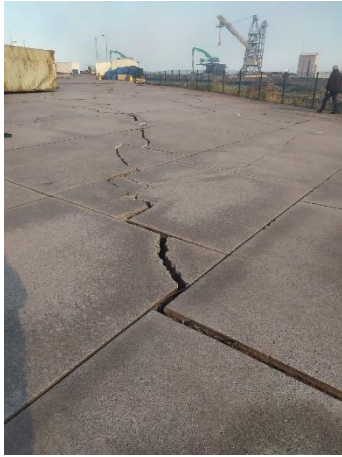
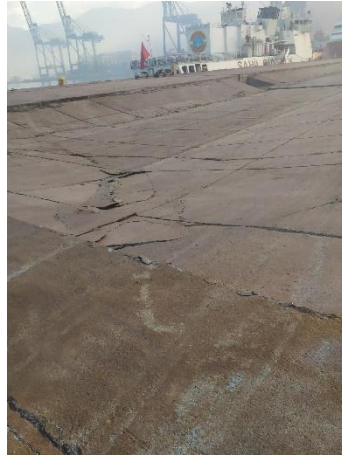
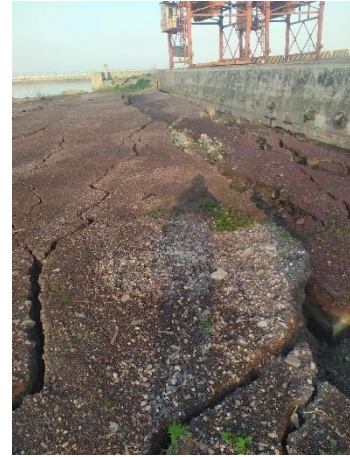
**Figure 4.2.** Seismic soil liquefaction induced lateral spreadings in **a)** Çay District / İskenderun / Hatay ( $36.59281^{\circ}N$ ,  $36.185977^{\circ}E$ ), **b)** Özerli District / Dörtyol / Hatay ( $36.81294^{\circ}N$ ,  $36.18123^{\circ}E$ ), **c)** Fatih District / Gölbaşı / Adıyaman ( $37.78023^{\circ}N$ ,  $37.62858^{\circ}E$ ), **d)** İskenderun Port Area / Hatay ( $36.59991^{\circ}N$ ,  $36.19274^{\circ}E$ ), **e)** İskenderun Port Area / Hatay ( $36.59991^{\circ}N$ ,  $36.19274^{\circ}E$ ), **f)** İskenderun Port Area / Hatay ( $36.59991^{\circ}N$ ,  $36.19274^{\circ}E$ ).

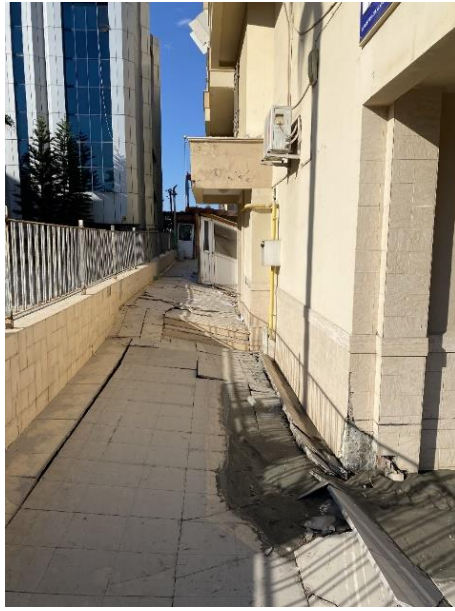
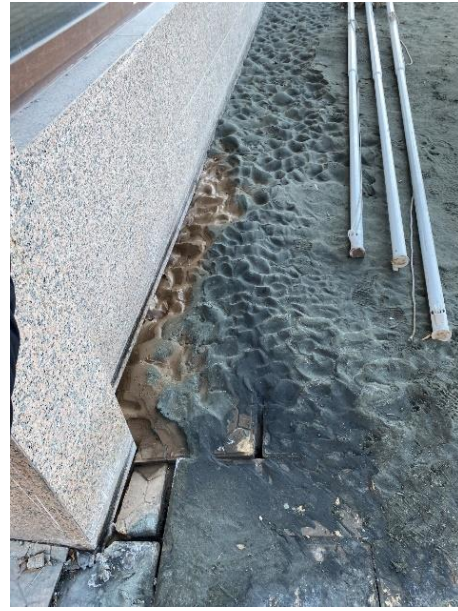
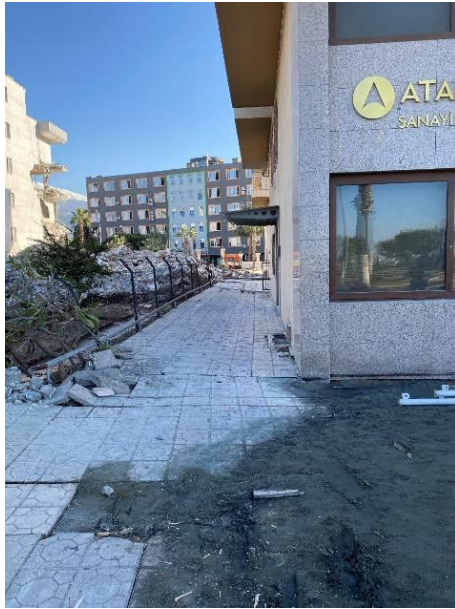
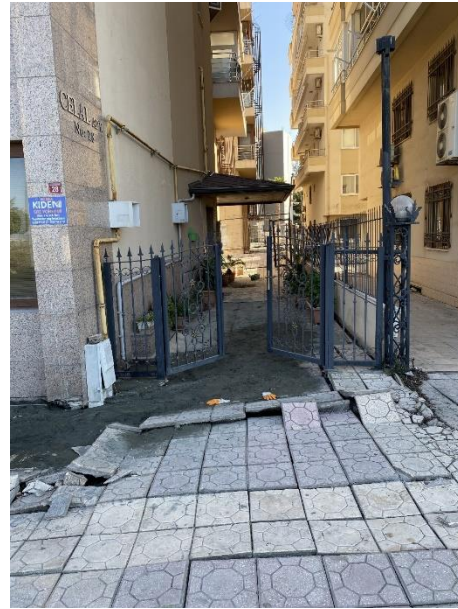
**Figure 4.3.** Seismic soil liquefaction-induced induced foundation problems in **a)** Çay District / İskenderun / Hatay ( $36.5911^{\circ}N$ ,  $36.1790^{\circ}E$ ), **b)** Çay District / İskenderun / Hatay ( $36.5911^{\circ}N$ ,  $36.1790^{\circ}E$ ), **c)** Çay District / İskenderun / Hatay ( $36.5911^{\circ}N$ ,  $36.1790^{\circ}E$ ), **d)** Çay District / İskenderun / Hatay ( $36.5911^{\circ}N$ ,  $36.1790^{\circ}E$ )

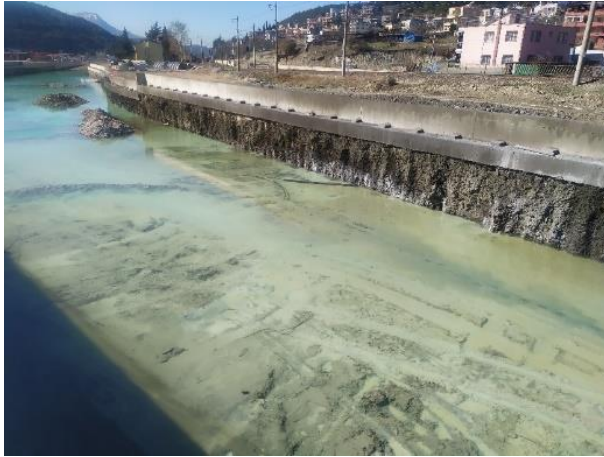
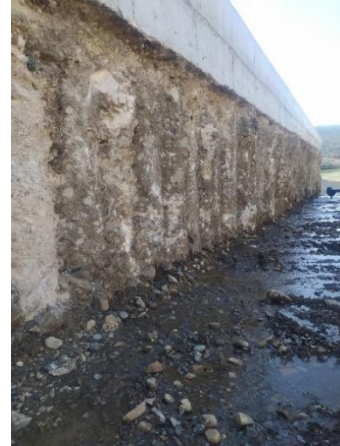
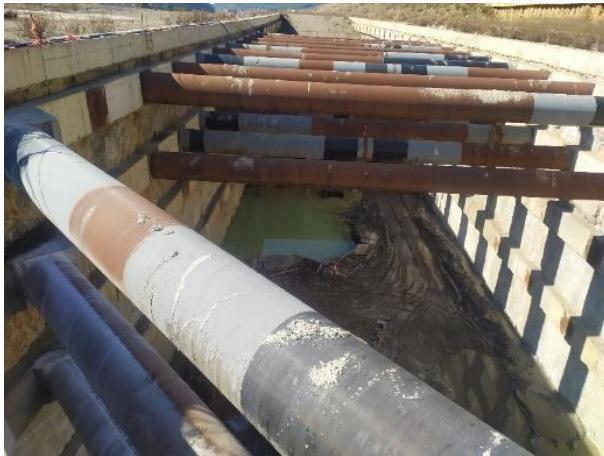
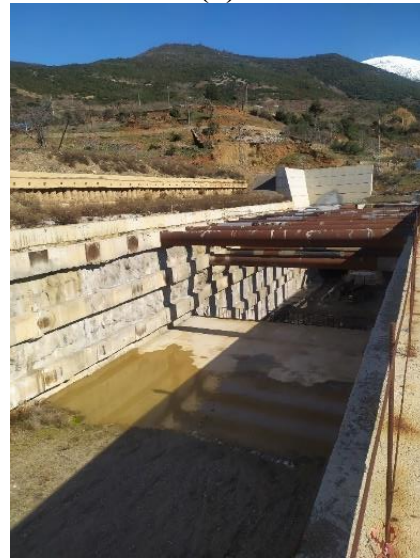
The performance of deep excavation systems on the route was also investigated. Figure 4.5 (a) and (b) display Osmaniye-Bahçe underpass, which was supported by cantilever reinforced concrete pile elements. No significant deformations were observed in the deep excavation support system. Next to the site, there exists a tunnel portal structure. Figures 4.5 (c) and (d) show the portal structure supported by reinforced concrete piles and strut elements.

**Figure 4.5.** Examples of deep excavations in **a)** Bahçe / Osmaniye ( $37.18845^\circ N$ ,  $36.56326^\circ E$ ), **b)** Bahçe / Osmaniye ( $37.18939^\circ N$ ,  $36.56402^\circ E$ ), **c)** Bahçe / Osmaniye ( $36.17313^\circ N$ ,  $36.59912^\circ E$ ), **d)** Bahçe / Osmaniye ( $36.17313^\circ N$ ,  $36.59912^\circ E$ )

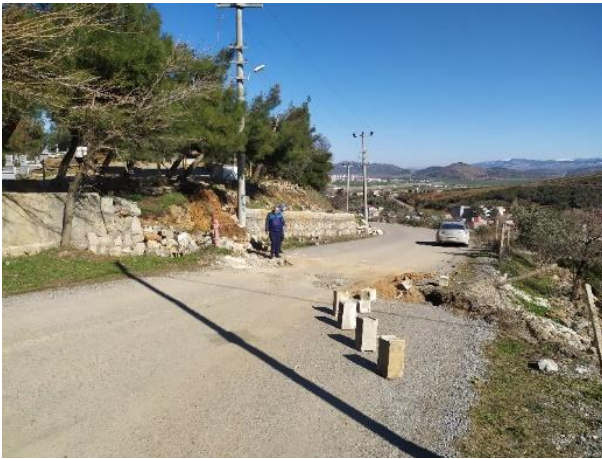
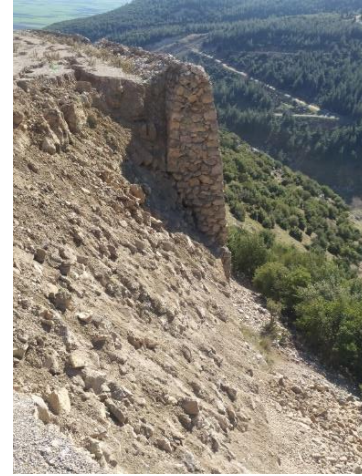
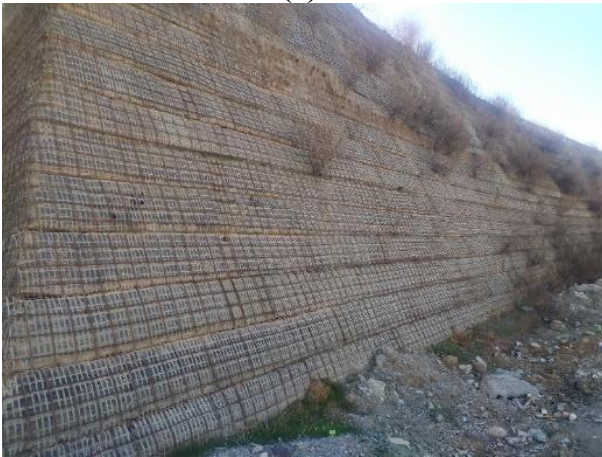
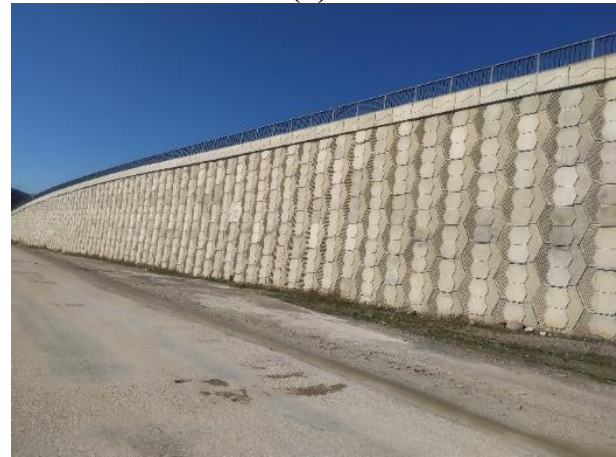
A limited number of tilted and/or partially collapsed and collapsed walls were also observed. Some stone walls supporting highway cuts and fills were deformed or fully collapsed as shown in Figures 4.6 (a) and (b). However, mechanically stabilized earth fill walls widely used as approach fills for bridges perform extremely well under peak ground acceleration levels in excess of 1 g in Fevzipaşa as shown in Figures 4.6 (c) and (d).

**Figure 4.6.** Some examples of retaining structures in **a)** Gökçedere/ Gaziantep ( $37.16439^\circ N$ ,  $36.70672^\circ E$ ), **b)** Gökçedere/ Gaziantep ( $37.16546^\circ N$ ,  $36.69749^\circ E$ ), **c)** Bahçe/ Osmaniye ( $37.18853^\circ N$ ,  $36.56389^\circ E$ ), **d)** Bahçe/ Osmaniye ( $37.18844^\circ N$ ,  $36.56476^\circ E$ )

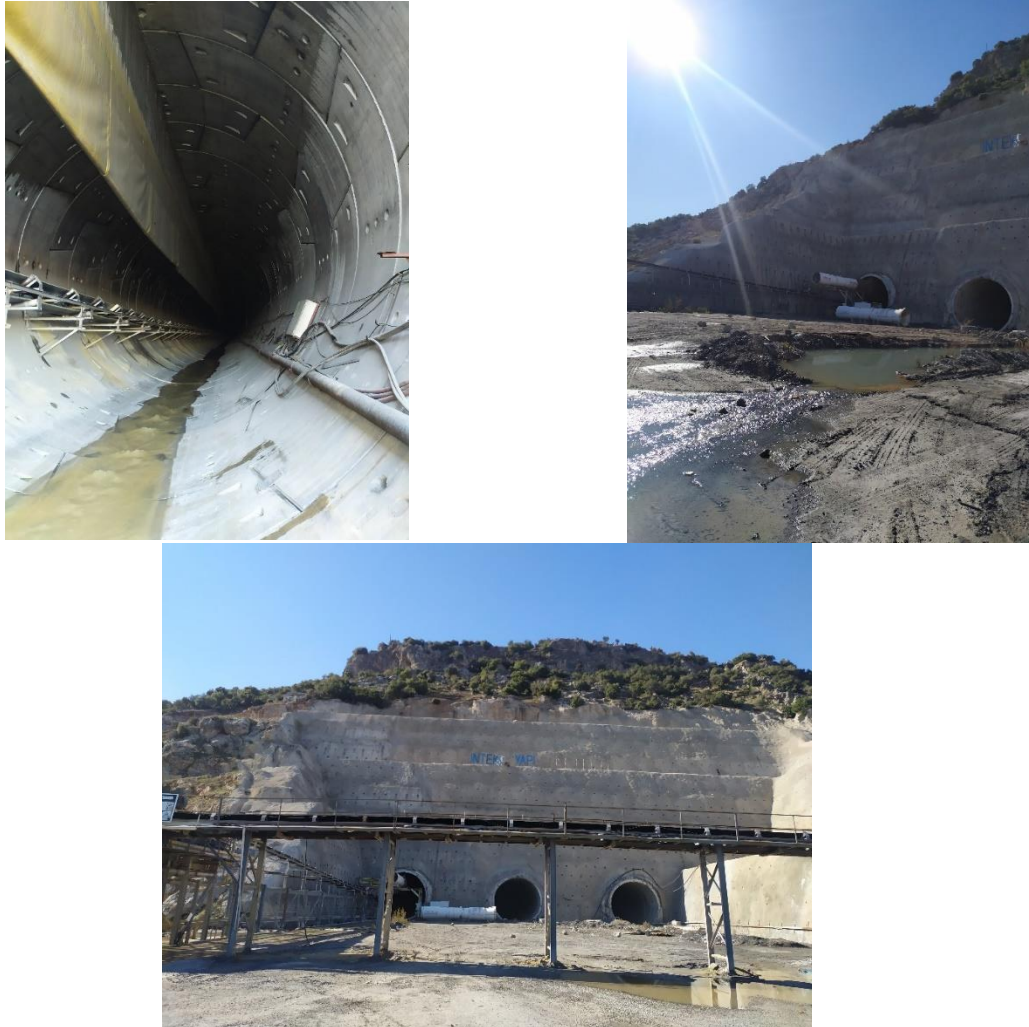
Tunnel structures in general performed well during and after the event. Except for minor damage observed in Erkenek tunnel lining, no major deformations were mapped. Some pictures from ongoing Bahçe-Nurdağ railway tunnel construction site are shown in Figure 4.8. The structural

and geotechnical performance of them is reported to be superior. More about tunnels will be discussed in Chapter 6.

**Figure 4.8.** Bahçe-Nurdağı railway tunnels under construction in Nurdağı/ Gaziantep (37.16989°N, 36.70806°E)

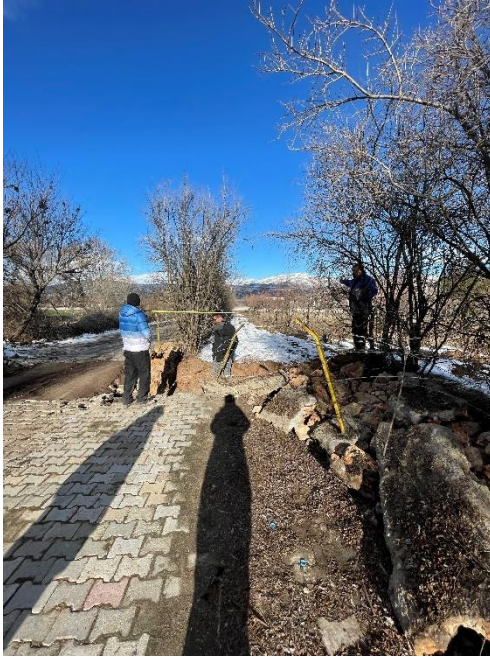
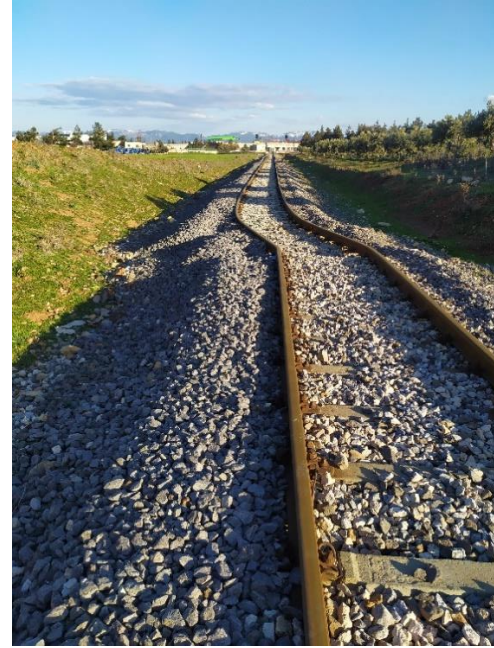
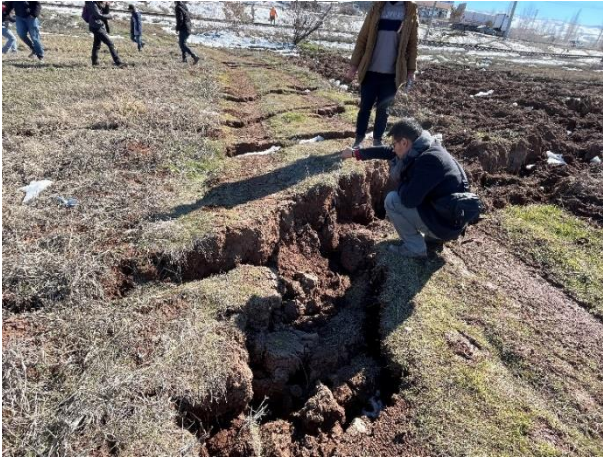
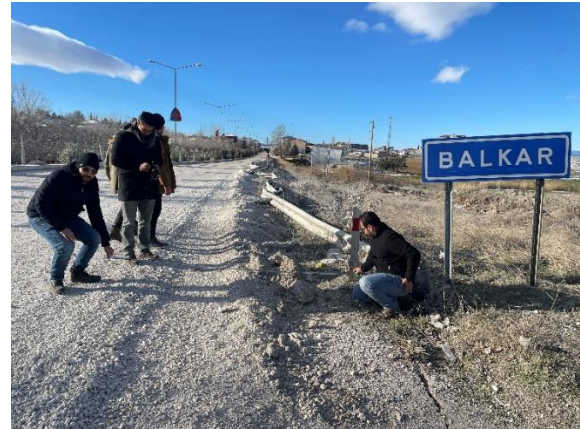
Along the route, several ground deformations either due to primary, secondary, or tertiary faulting or due to seismic soil liquefaction were mapped. Figures 4.10 (a) through (d) display these ground deformations.

**Figure 4.10.** Observation of surface rupture trace in **a)** Balkar / Adıyaman ( $37.73610^{\circ}N$ ,  $37.56842^{\circ}E$ ), **b)** Erenler District / İslahiye / Gaziantep ( $37.03931^{\circ}N$ ,  $36.62868^{\circ}E$ ), **c)** Yavuz Selim District / Adıyaman ( $37.79645^{\circ}N$ ,  $37.66021^{\circ}E$ ), **d)** Balkar / Adıyaman ( $37.73492^{\circ}N$ ,  $37.56617^{\circ}$ )

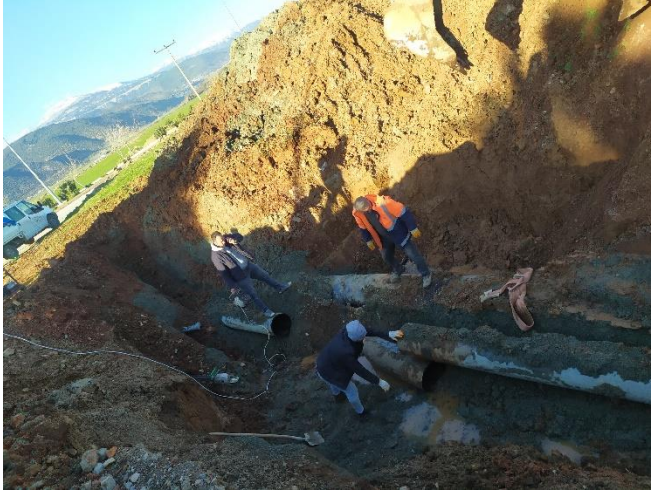
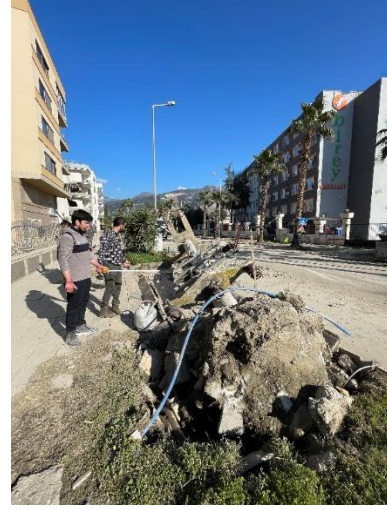
Pipelines were observed to be damaged after the earthquakes and some examples of the damaged pipeline and cables are shown in Figures 4.11 (a) and (b).

**Figure 4.11.** Pipeline damages in a) Erenler District / İslahiye / Gaziantep ( $36.04621^{\circ}N$ ,  $36.62936^{\circ}E$ ), b) Çay District / İskenderun / Hatay ( $36.59038^{\circ}N$ ,  $36.17893^{\circ}E$ )

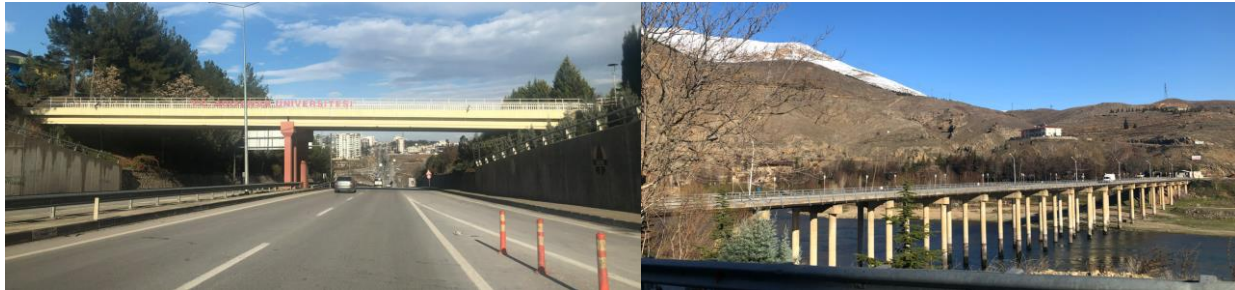
**Figure 6.8.** Bridge typical have no damage

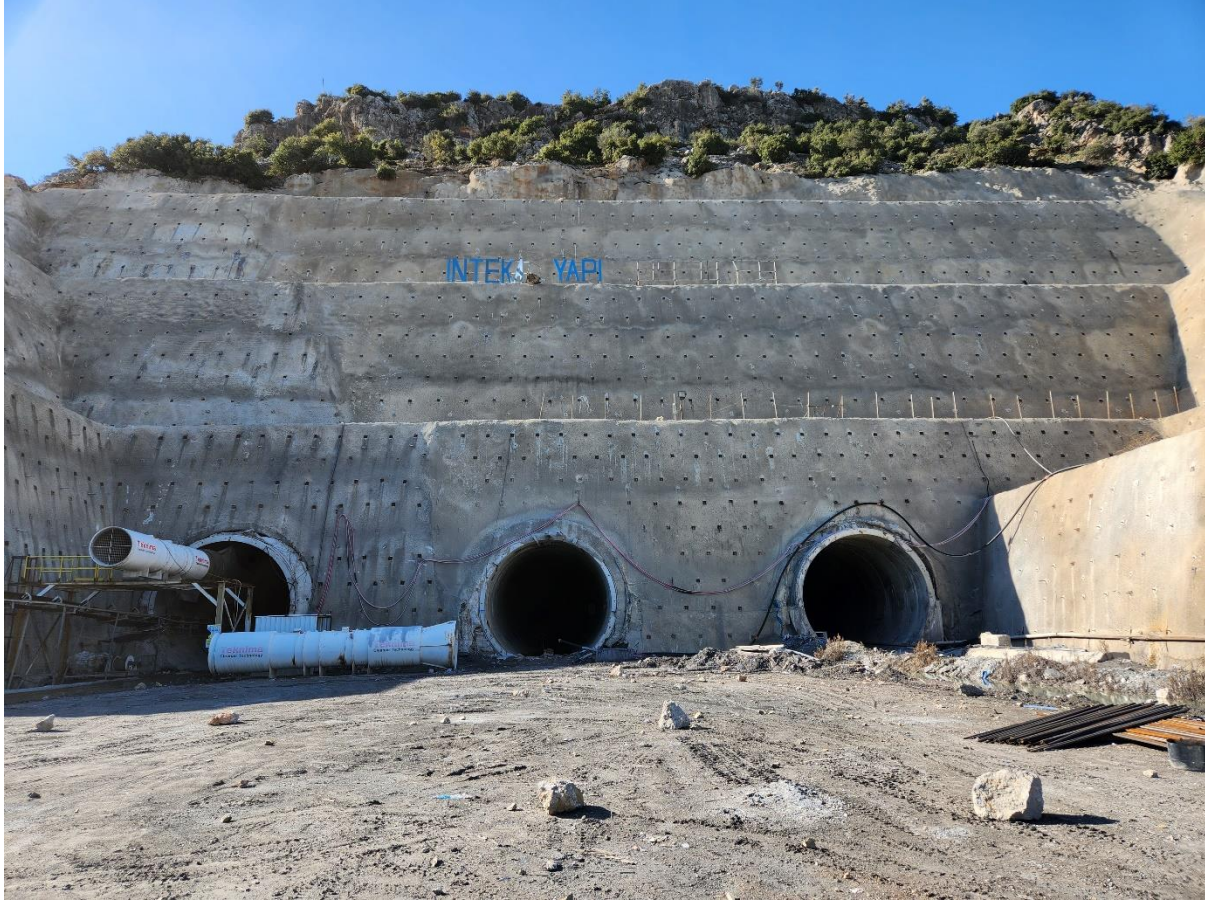
**Figure 6.10.** Nurdağı portal of Bahçe-Nurdağı railway tunnels

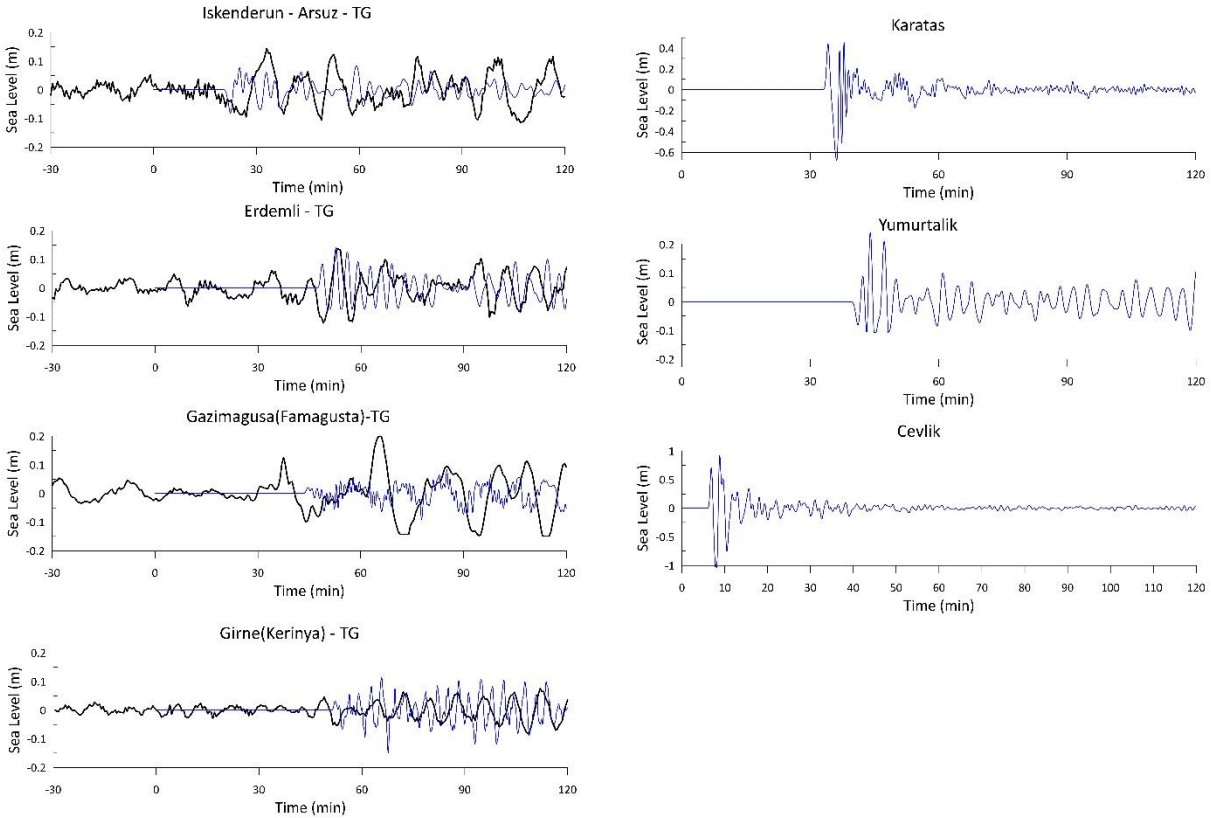
Simulations are performed using the survey findings and the numerical results are compared with the tide gauge measurements. Figure 7.2 shows the comparison of the measured (black) and computed (blue) time histories at four tide gauge stations. The additional time histories of modeling results are presented for the localities near Karataş, Yumurtalık, and Çevlik fishery ports, where the eyewitness observations are collected from the fishermen or coast guard staff. The arrival times of the first wave nearly fit with the measured data. However, more detailed modeling studies are required to determine the location and type of the source when new data is collected by new field studies.

**Figure 7.2** The comparison of the measured (black) and computed (blue) time histories of water surface fluctuations at four tide gauge stations (first column) and computed time histories near Karataş, Yumurtalık and Çevlik fishery ports, where only eyewitness observations (second column) could be obtained.

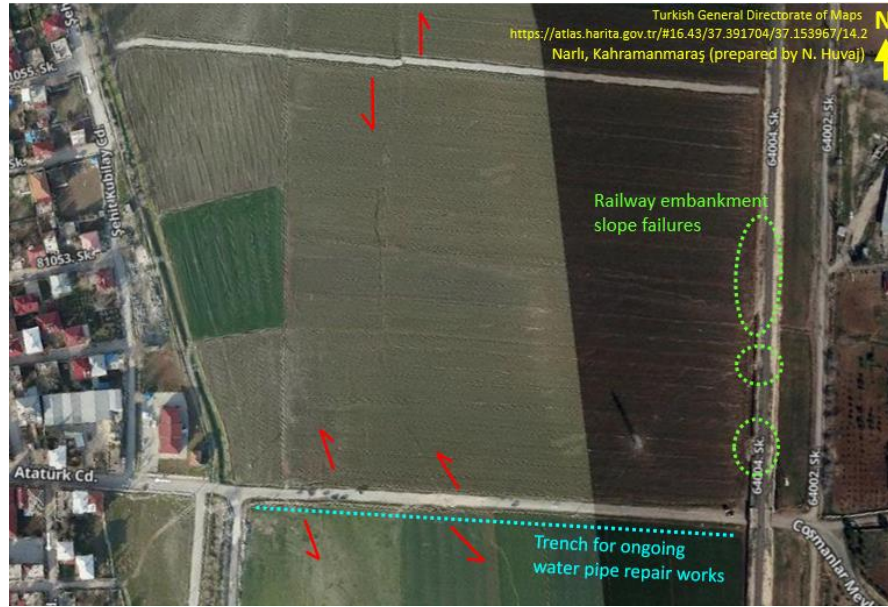
**Figure 8.2.** Areal view of the surface fault rupture and examples of damages caused by the two earthquakes on some of the lifelines: railway line, roads and water distribution network, near Narlı, Kahramanmaraş (Satellite images are provided by Turkish General Directorate of Maps via atlas.harita.gov.tr website)

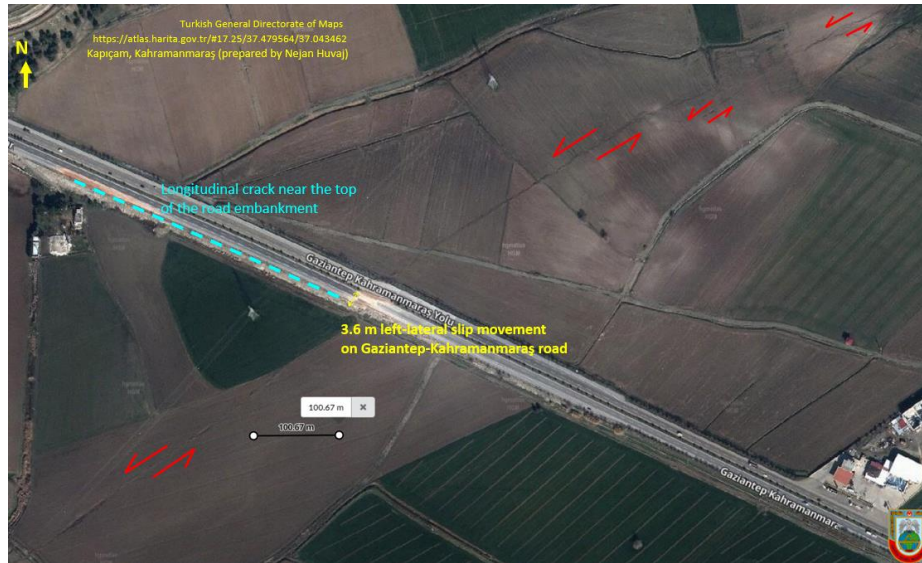
**Figure 8.6.** Surface rupture observations causing a 3.6 m offset on Gaziantep-Kahramanmaraş road, cracks on the asphalt road at several locations, road embankment instability and more than 250 m-long longitudinal cracks at the top of the road embankment as well as on the asphalt road, near Kıpıçam, Kahramanmaraş (Satellite images are provided by Turkish General Directorate of Maps via atlas.harita.gov.tr website)

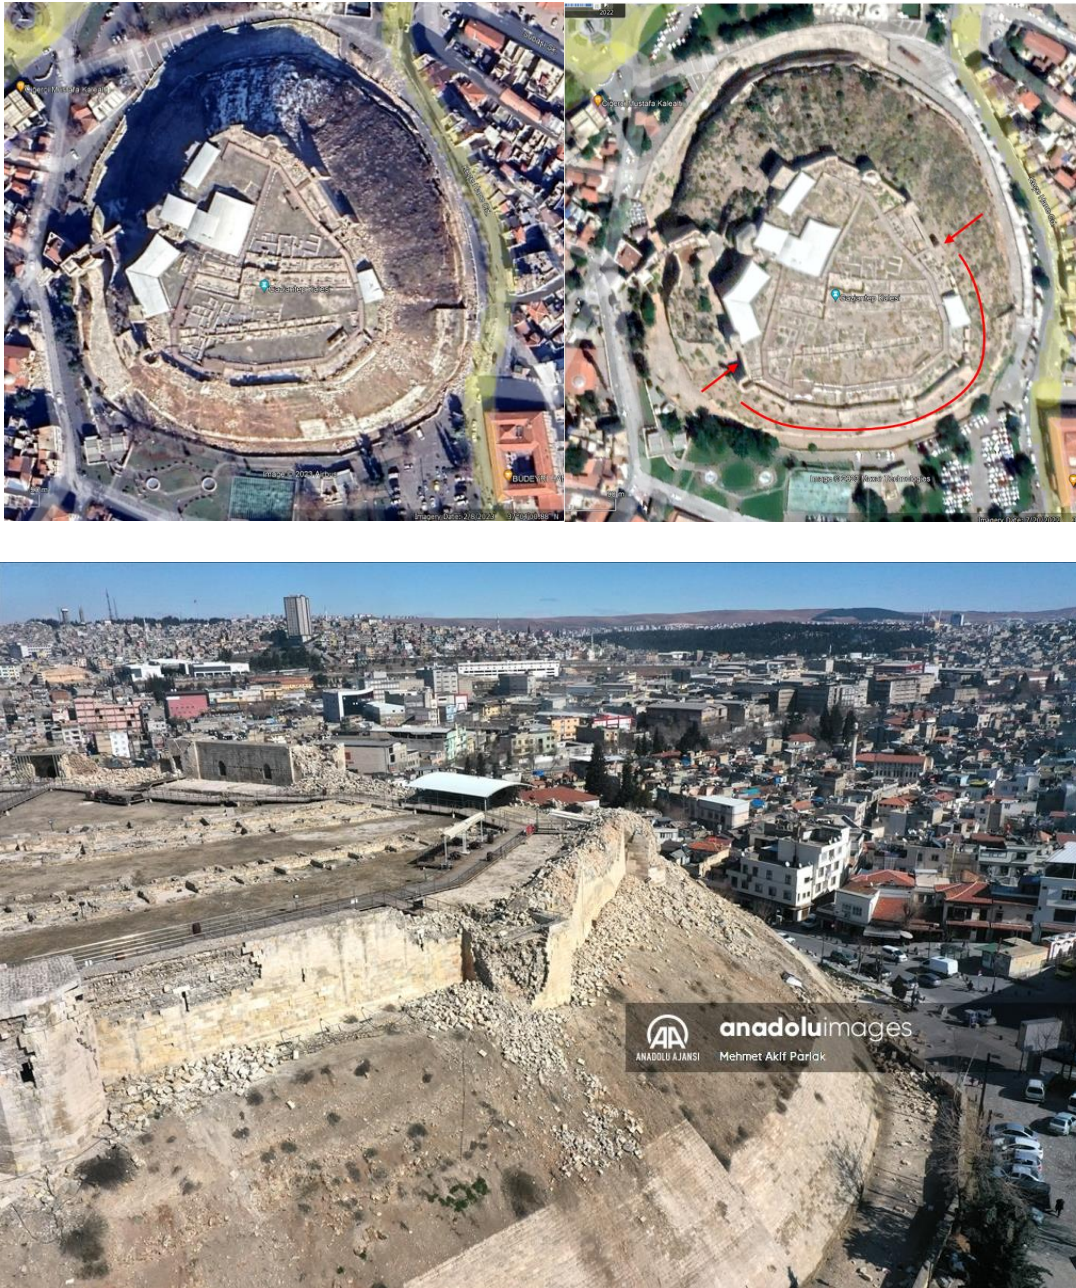
An important historic heritage located in south eastern Türkiye is Gaziantep Castle (**Figure 9.5.**). Unfortunately, Gaziantep to the epicenter of the first earthquake is only about 32 km and the second earthquake is about 115 km distance. The orientation of the castle walls to the earthquake epicenter

may be the reason for south-west castle walls to suffer the largest damage when the first impact must have pushed these walls and sending wall stones towards the slope towards the city. It is fortunate that the castle wall stones did not cause major damage to people, houses, businesses at the skirts of the castle. The castle being located at the top of a hill may also had lens action amplifying the pga and damaging effects of the earthquakes.

**Figure 9.5.** Gaziantep Castle before and after the earthquakes.

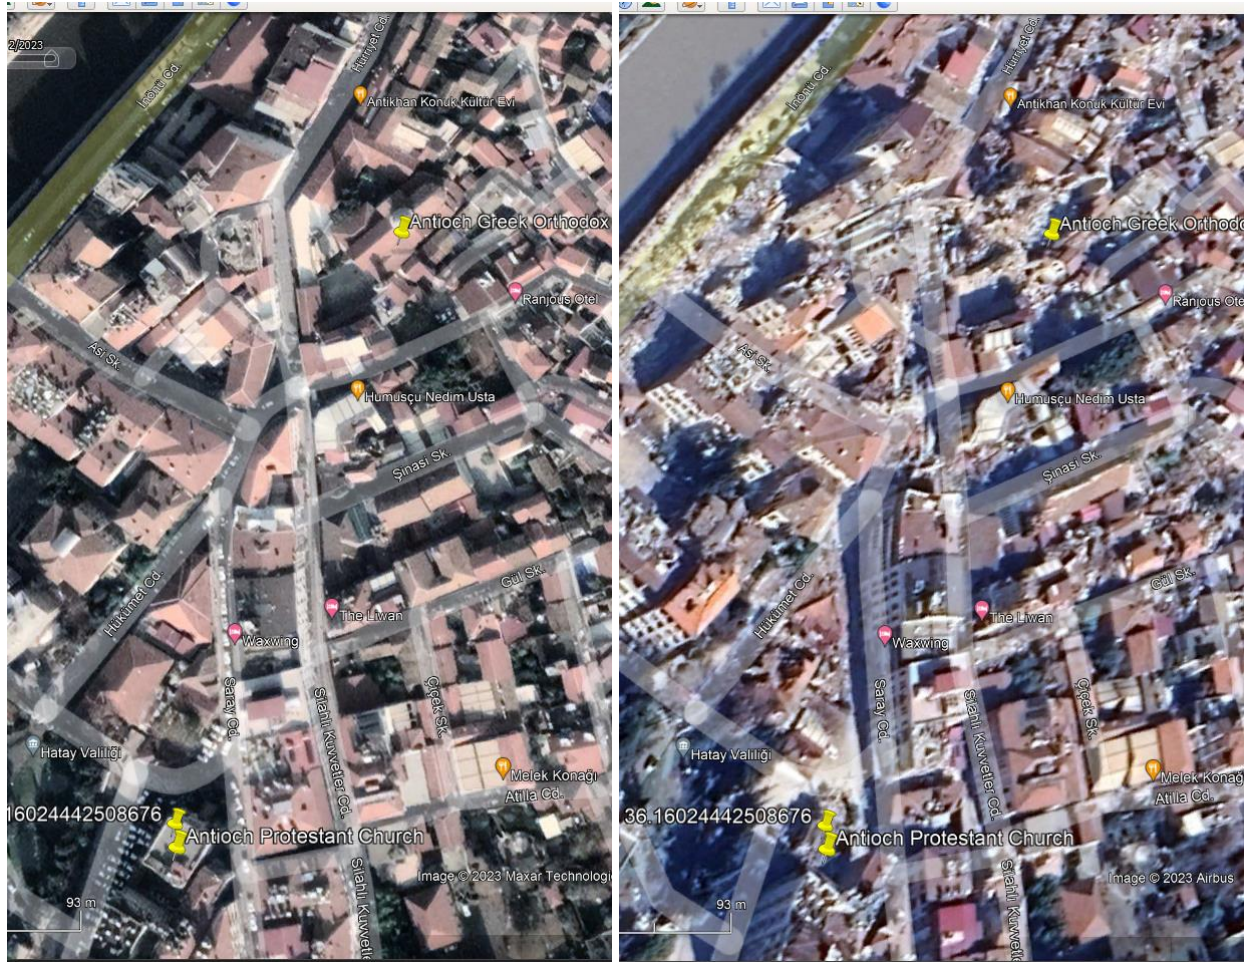
Last examples of historic structures were selected from Hatay region. The Antakya Rum Orthodox Church (Antioch Greek Orthodox Church) and Antakya Protestant Church are located very close to each other within 150 meters, and both suffered significant damage during the earthquakes. The distances between the churches and the first and second earthquakes are about 135 km and 225 km respectively. Satellite images before and after the earthquakes (**Figure 9.6.**)<sup>4</sup> indicate that both structures suffered immense damage. The after-earthquake picture of the Antakya Rum Orthodox Church (**Figure 9.7.**) shows total roof collapse while only west wall and partial south cylindrical walls are standing. The collapsed picture of the Antakya Rum Orthodox Church also shows roof collapse with probably south wall collapse. The epicenter to the historic structures distances is comparable between Malatya and Hatay, both cities with significant damage to their historic buildings. Majority of the mosques showed acceptable performance in Malatya (exception of Yeni Cami) while both studied churches suffered major damage in Hatay.

Figure 9.6. The Antakya Rum Orthodox and Protestant Churches Before and After Earthquakes

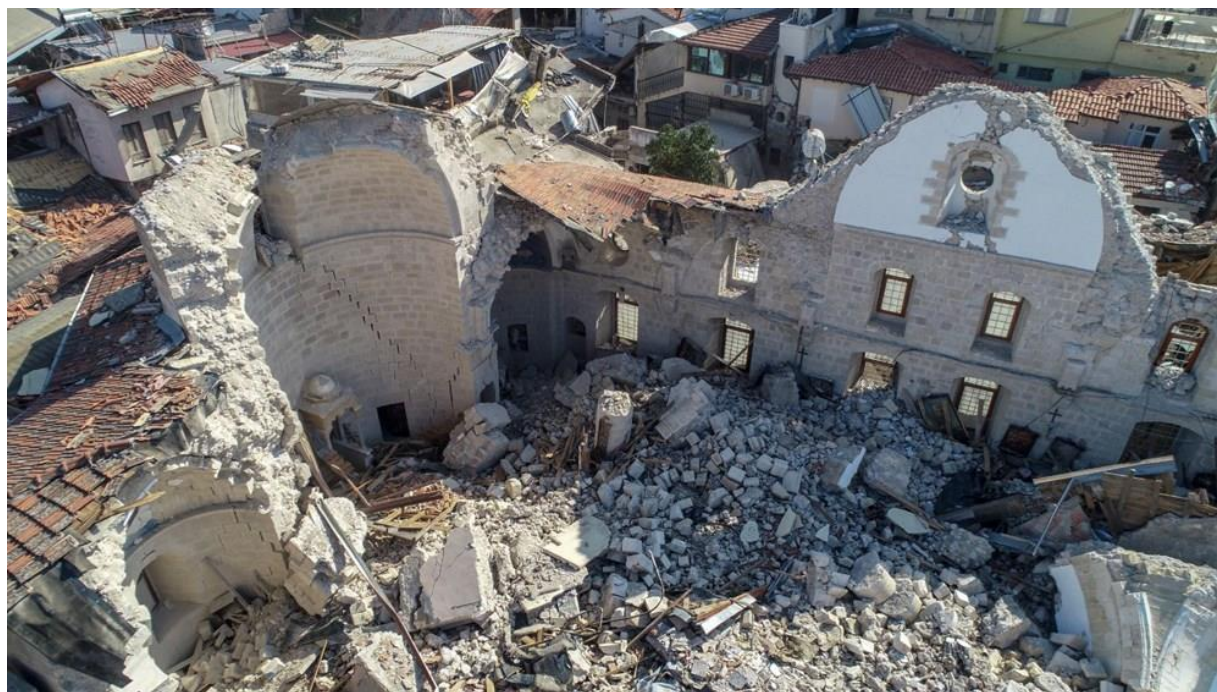
**Figure 9.7.** The Antakya Rum Protestant Church after the earthquake

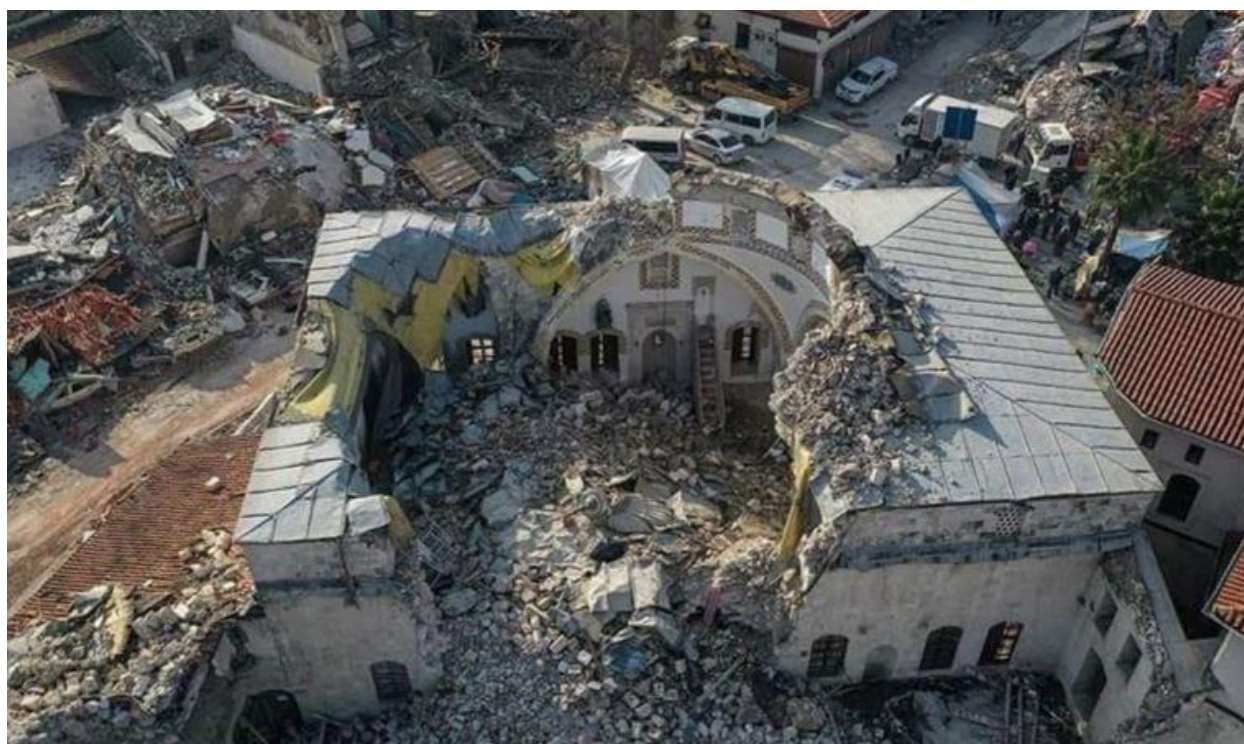
**Figure 9.8.** The Antakya Rum Orthodox Church after the earthquake
